Havarikommisjonen
Accident Investigation Board Denmark

BULLETIN

Serious incident

PH-KZD

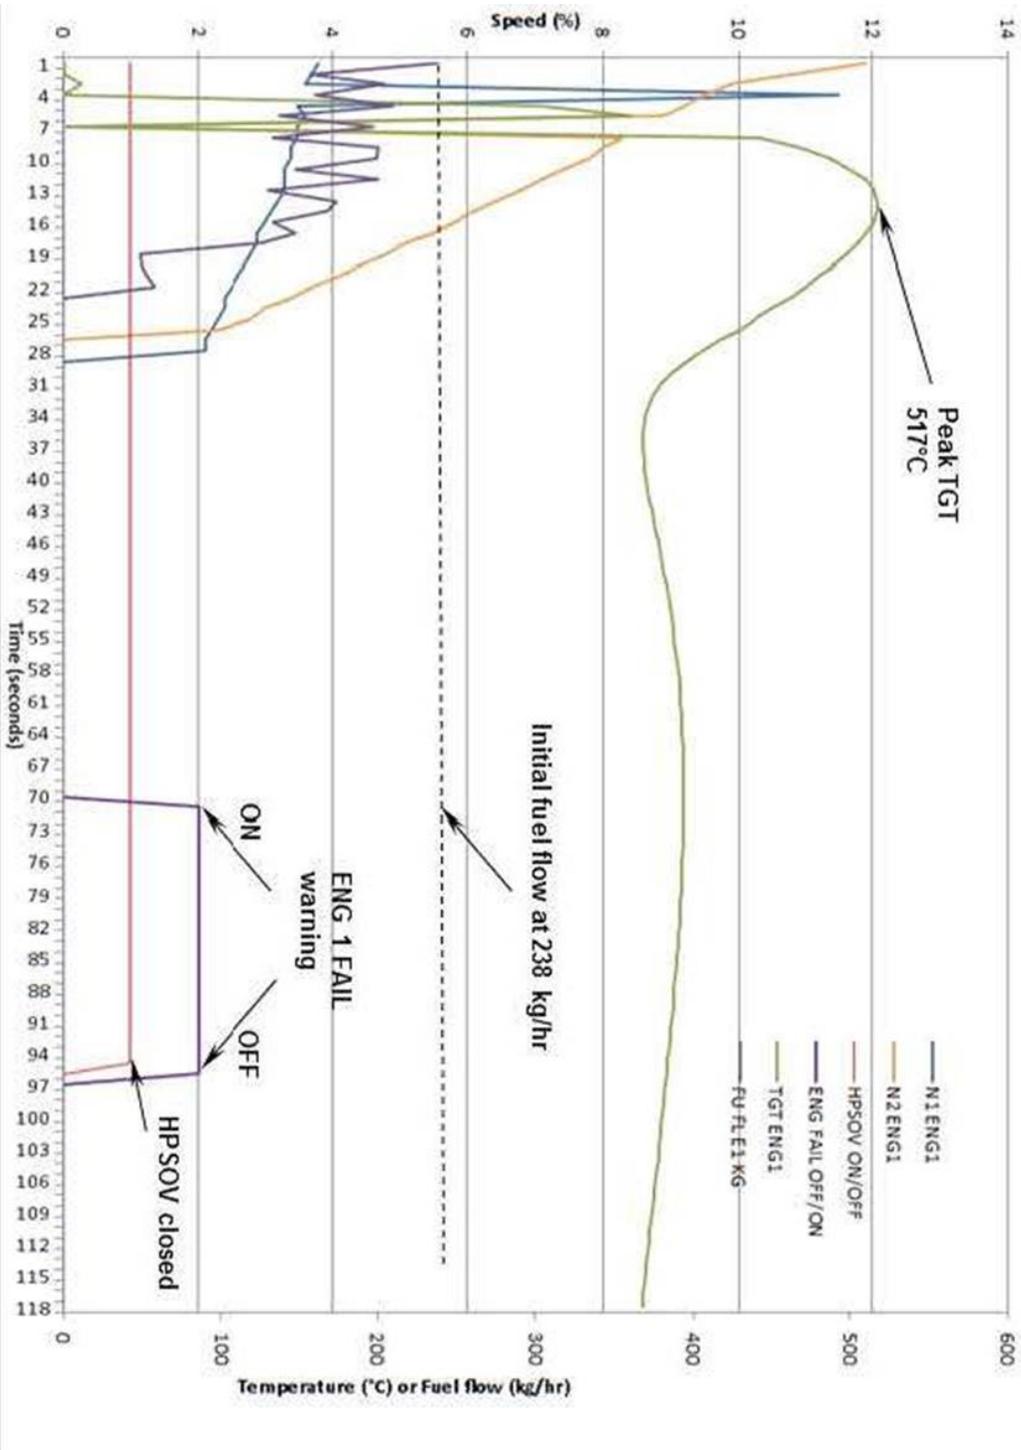
Appendix 1

The first data point, recorded at 05:25:26 showed the HP (N2) system spool speed to be 11,9% from which point, the speed steadily decreased during the following over 26 seconds until a zero rotation speed was indicated. Similarly, the LP (N1) spool speed steadily decreased from 3,8% to zero during the first 28 seconds of the recorded data.

From the start of the recording, the data showed that the fuel flow to engine no.1 was 238 kg/hr. steadily decreasing to zero during the following 22 seconds, effectively corresponding to the decreasing HP spool speed. This evidence showed that engine no.1 High Pressure Shut of Valve (HPSOV) was open throughout this period. (The data showed that the engine no.2 HPSOV was closed during this period).

From the first recorded data point, the engine TGT rapidly increased from 1° C to 517° C within 13 seconds, indicating that the fuel was ignited, but the HP and LP spool systems did not accelerate in response. Following the peak at 517° C (limitation 700° C), the TGT slowly decreased until it

stabilized at approximately 390° C, indicating the TGT thermocouples were still recording an increased, but reasonably constant temperature.

41 seconds after the N2 speed was recorded to zero, the ENG 1 FAIL appeared. For a time period of 24 seconds after the ENG 1 FAIL warning was recorded, the engine no.1 HPSOV was not closed. (See appendix 1 page 10).
