Havarikommissionen
Accident Investigation Board Denmark

BULLETIN

Gyrocopter

OY-1034

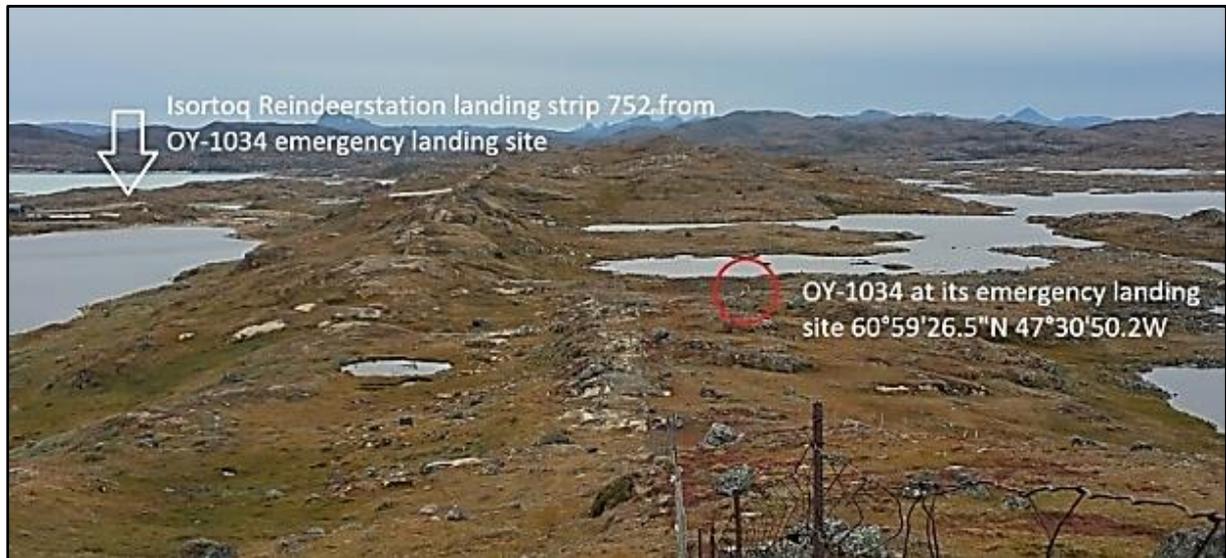
Accident site

In order to regain airspeed, the pilot lowered the nose of the gyrocopter and manoeuvred the gyrocopter into a rocky landing site in front of the gyrocopter.

The tail/rudder hit a rock on the ground and bent upwards and hit the propeller and the radiator.

The gyrocopter continued forward flying, and the rotor hit the ground.

The gyrocopter came to rest on its left side.

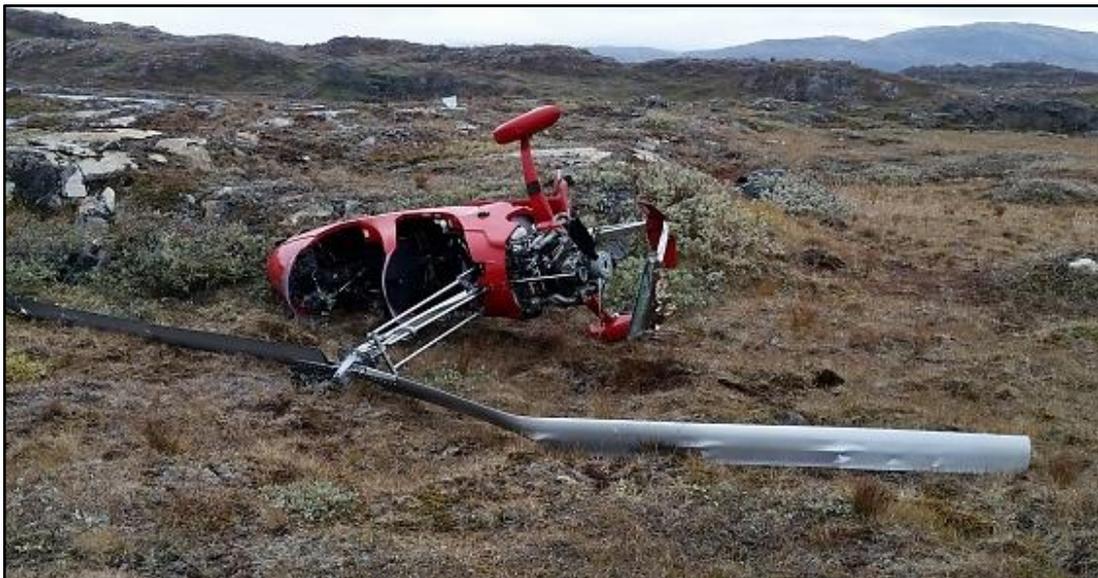
Wreckage

The gyrocopter was destroyed.

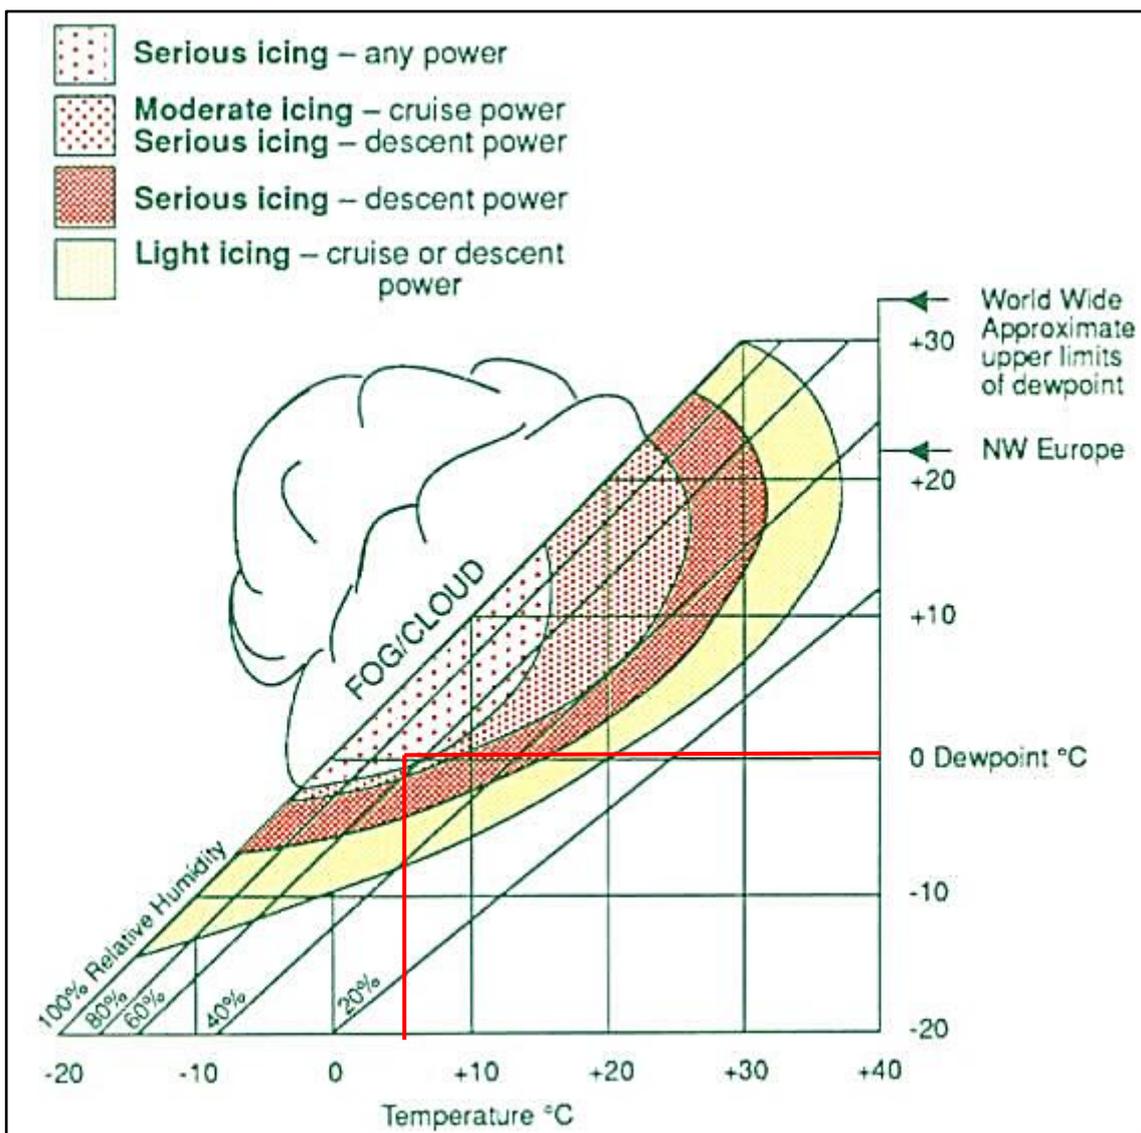
Risk of carburettor icing

However, the risk of serious carburettor icing at any power was present.

Taking into consideration the temperature (pilot reported) and the dewpoint (METAR BGBW) on the day of the accident, a potential scenario might be carburettor icing contributing to the pilot experience of a sudden loss of engine power.
