**FINAL REPORT**

<b>HCLJ510-2013-200</b>	<b>Serious incident</b>	
Aircraft:	Partenavia P68 Observer	Registration: OY-SUR
Engines:	2 Lycoming IO-360- A1B6	Flight: Other, VFR
Crew:	1 – No injuries	Passengers: None
Place:	5 nm north of ODIN VOR Fyn	Date and time: 24.4.2013 at 06:56 UTC

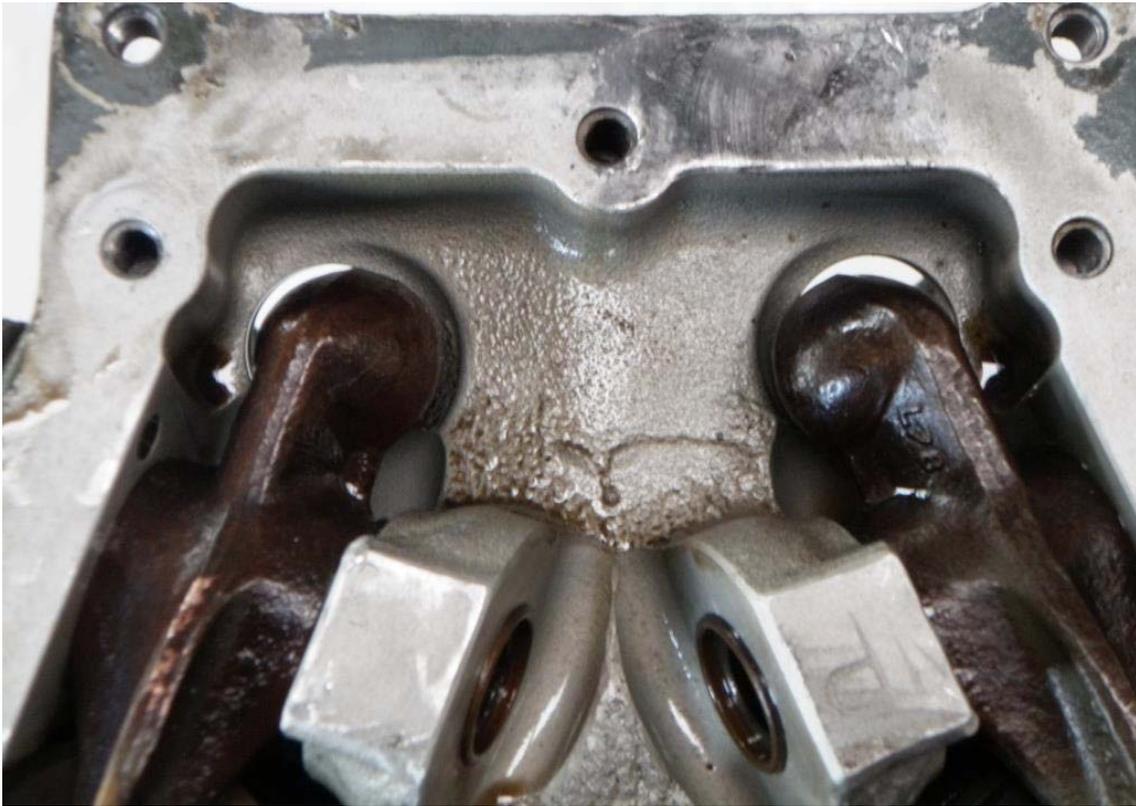
The picture next page shows the rocker arm installation of cylinder # 3.

It can be seen, that the rocker arms are displaced inwards and not aligned with the push tube bores in top of the cylinder.

The exhaust rocker arm was installed on the intake side and vice versa.

In addition it was revealed, that the push tubes were forced to operate in a displaced inward position.

The engine examination revealed that because the exhaust and the intake rocker arms were interchanged, the push tubes were forced to be misaligned in the push tube bores.

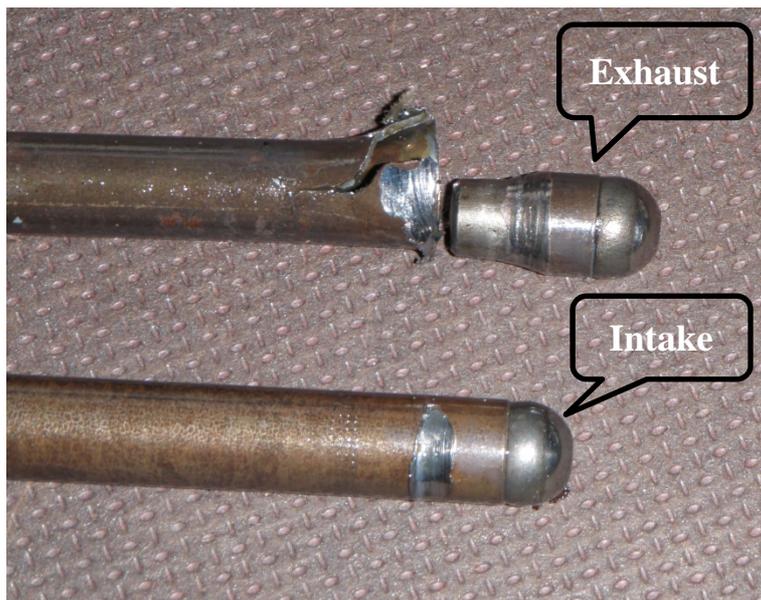
As can be seen on the picture below, the exhaust valve push tube was damaged and broken up. The intake valve push tube had impact wear marks on the top end of the tubing. It was revealed that this damage was a result of contact with the top end of the push tubes in the push tube bores of the cylinder.

Every time the valves were opened by the push tubes, the tubes came in contact with the push tubes in top of the push tube bores of the cylinder.

Over time (almost 50 hrs.) this caused damaged to the push tubes and finally caused the exhaust push tube to break up.

As a result hereof the exhaust valve could no longer be opened.

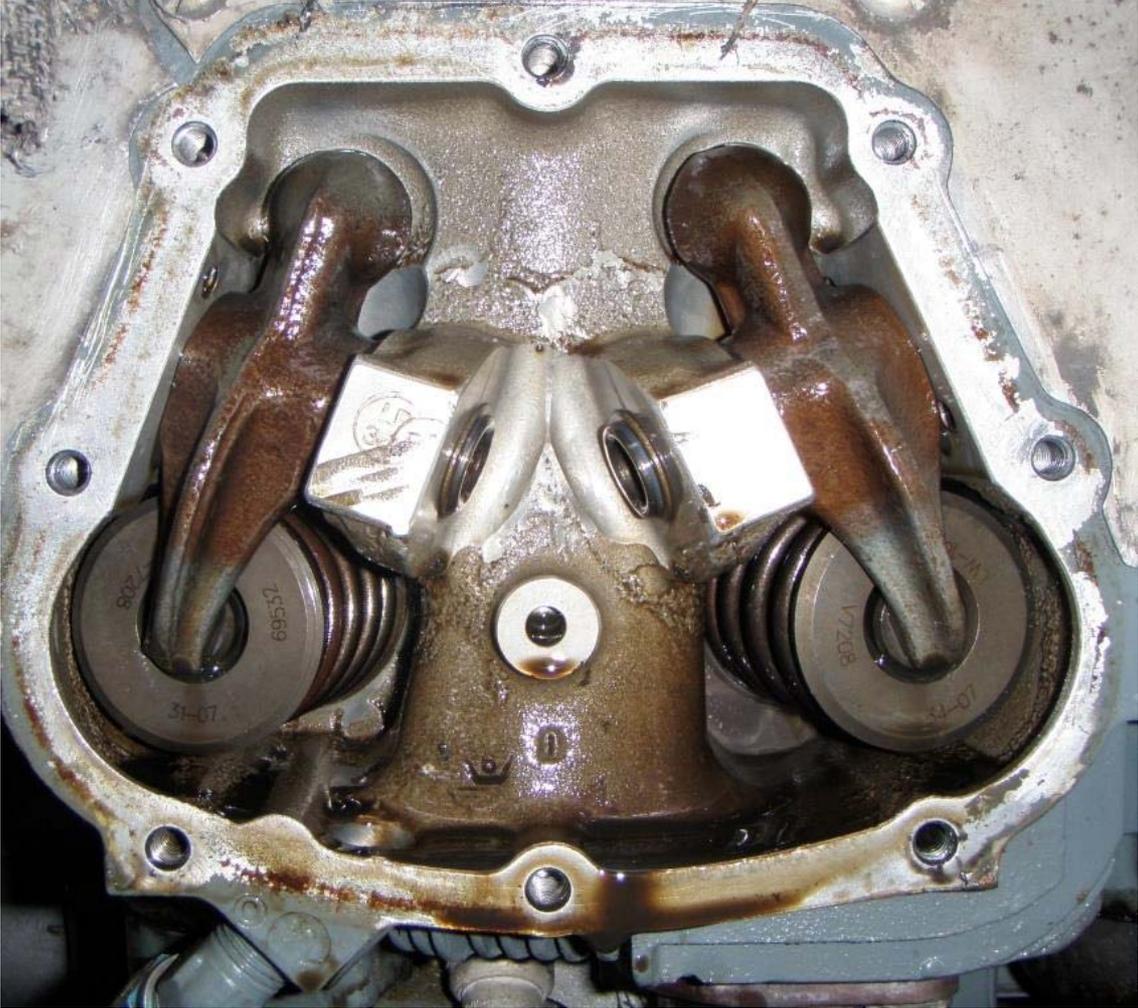
The picture below shows the rocker arms installation of another cylinder (Intake left and exhaust right). Note that the rocker arms are aligned with the push tube bores.

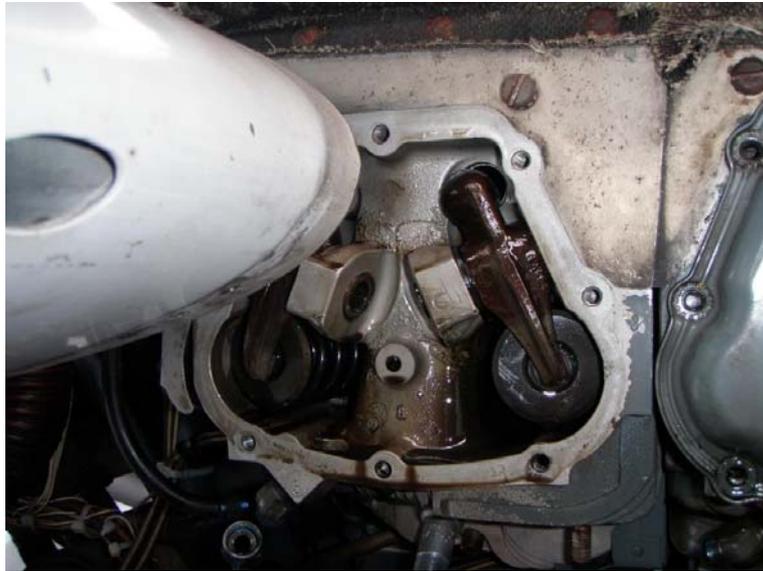
As shown on the picture below, cylinder # 3 was partly hidden by the leading edge of the left wing.

According to the maintenance shop, the repaired cylinder was installed on the engine without the rocker arms attached to the cylinder due to lack of space on the aircraft.

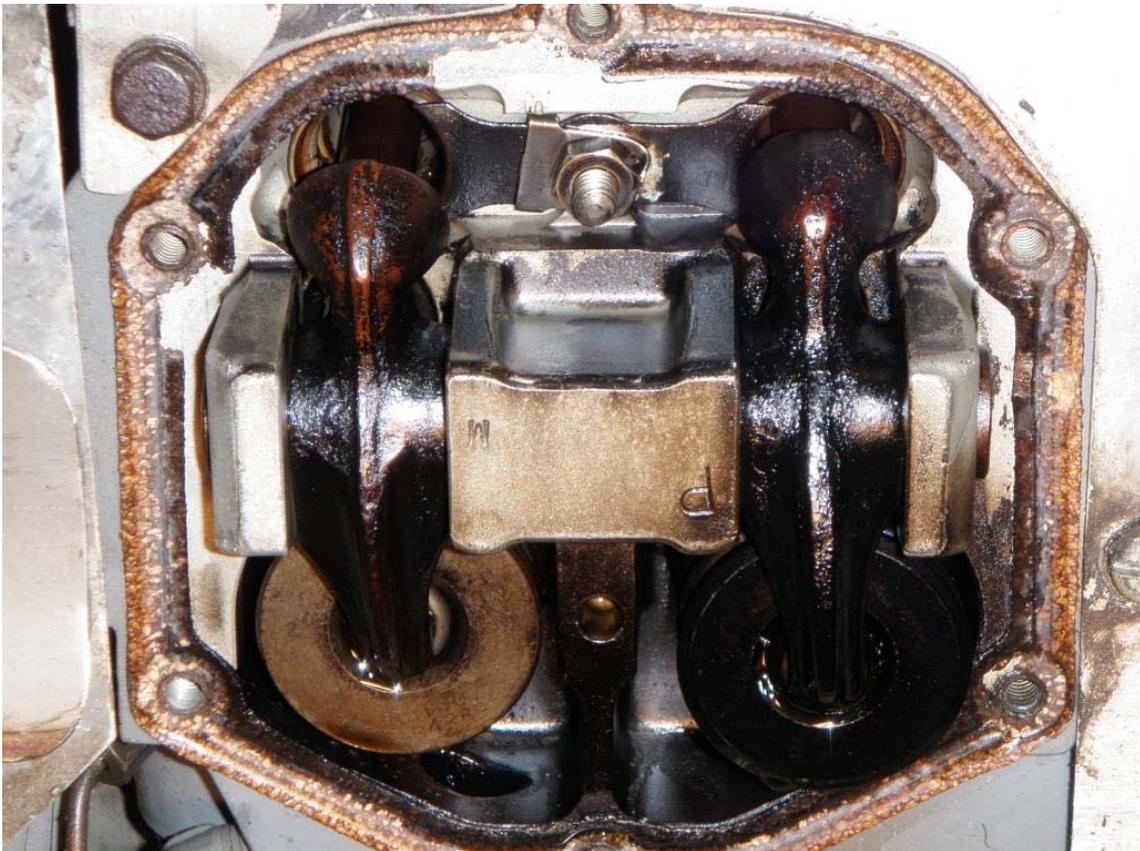
Unlike the rocker arms of the parallel valve cylinders where the intake and exhaust rocker arms are interchangeable, rocker arms are never interchangeable on the angle valve cylinders.

A parallel valve cylinder from another engine is shown below for comparison to the angle valve cylinder.
