## **FINAL REPORT of Civil Aviation Investigation**

OCCURRENCE TYPE	<b>Incident</b>
DATE AND TIME	11.12.2015 / 19:28 UTC; 22:28 LT
LOCATION	Kyiv/Zhulyany Airport (UKKK)
AIRCRAFT	Challenger 850 CL (CL-600-2B19)
REGISTRATION	OY-VGA
OPERATOR	ExecuJet Europe A/S

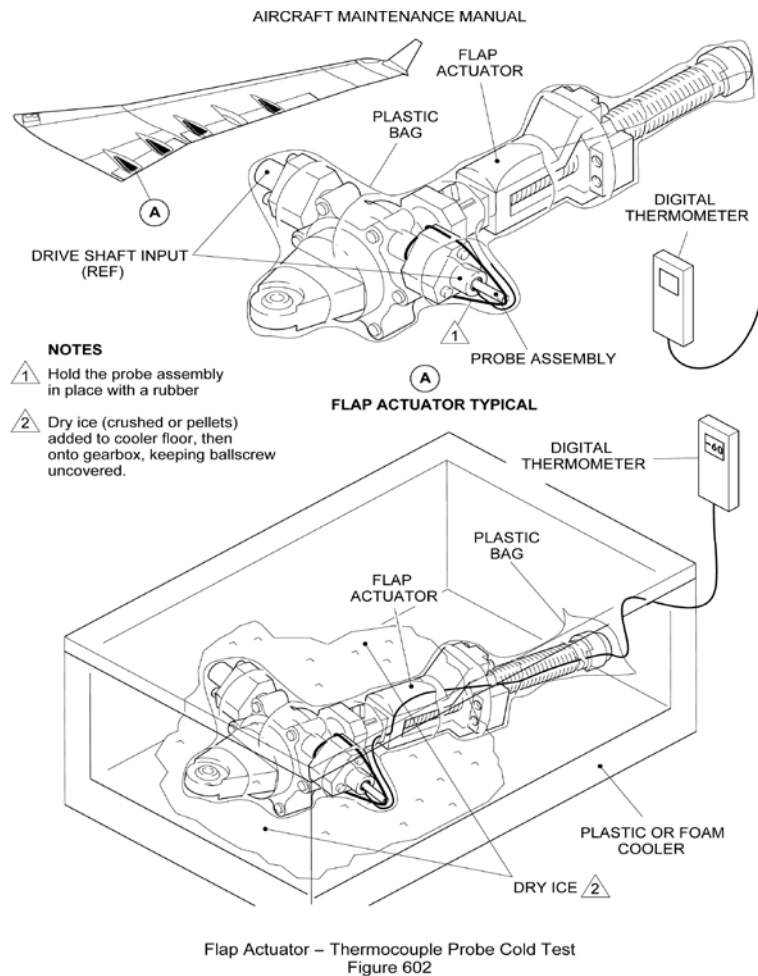
Fig. 6

In the course of carrying out the freezing test (Fig. 6), at cooling the drives to minus 60°C for not less than 2 hours, the maximum breakaway torque and maximum torque of the drive shaft were checked, which, under the specified conditions, should not exceed 15 inches/pound (1.69 Nm) and 13 inches/pound (1.47 Nm), respectively.

The check has shown that all flap actuators, except No. 2, have not passed the test of the maximum breakaway torque of the drive shaft. No. 2 flap actuator had a leak and upper limit of the maximum breakaway torque of the drive shaft. The test results were entered into CRS of 23.12.2015.

Inspection of cores of flexible drive shafts has shown that the flexible shaft of the left flap No. 1 had an excessive off-load torsion torque, and flexible shaft of the left flap No. 2 had corrosion from water ingress. Other flexible drive shafts of the left and right flaps had no defects and traces of moisture ingress.

- fault of eight flap actuators became the cause of flaps non-deployment (jamming in "0" degree position) in view of moisture ingress into the internal cavities of the drive mechanism and into cavities of flexible drive shafts No. 1 and No. 2 of the left flap.

The cause of flap non-deployment (jamming in "0" degree position) was a failure of eight flap actuators in view of moisture ingress into the internal cavities of the actuator mechanism, as well as into the cavities of the flexible drive shafts No. 1 and No. 2 of the left flap, which led to its freezing at the airplane operation in the conditions of low temperatures.

After replacement of eight flap actuators and two flexible drive shafts, the airplane was released to service.

- for prevention of the flap actuator system failures – to take into account the Designer's (Bombardier's) recommendations related to the system functioning, fault recovery and best operation practices - "CRJ200 Flap System, System Function, Troubleshooting and Best Practices", the section of "Main Failure Drivers."
