Havarikommisjonen
Accident Investigation Board Denmark

BULLETIN

SIKORSKY S61N

OY-HAG

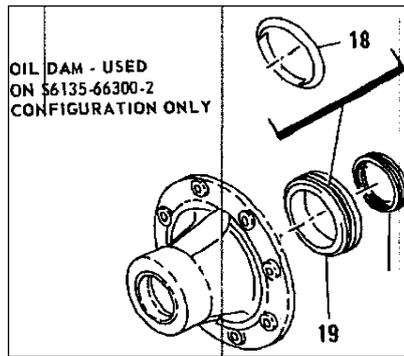
Oil dam

During the inspection, failure to the input gear bearing was found, and the input gear cone was overheated. Furthermore, the oil dam was found dented.

- The oil dam, all bearings, cups, cones, and packing's for the input and output seals were replaced.
- Oil lines were thoroughly checked to be clear of any contamination.

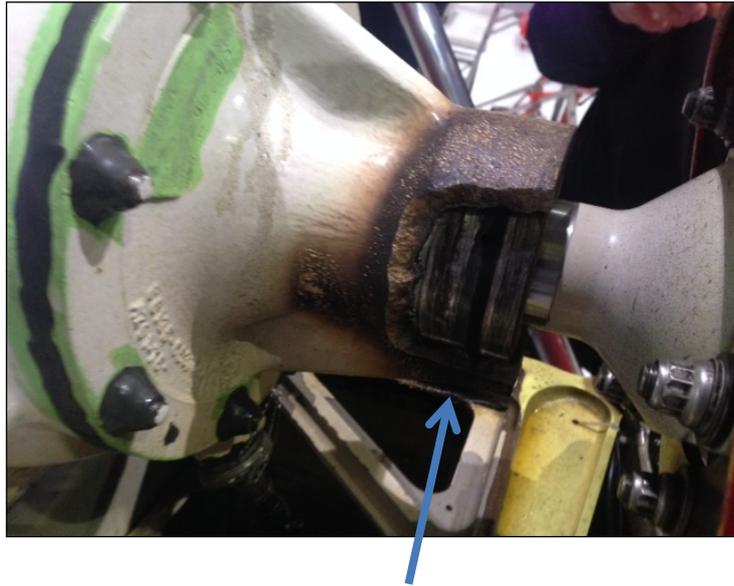
On the ramp, it was observed that the intermediate gear box was discolored from excessive heat around the area of the input bearing. A piece of approximately 10 by 4 centimeters of the intermediate gear box input housing had broken off.

The intermediate gear box input housing damage, and discoloring.

There was no history of this type of failure mode (over-heat fracture) with the subject GB (IGB: S6135-66300-002). Transmission Engineering concurs with the MET lab conclusion that the failure was potentially due to maintenance related issue, in this case excessive preload of the subject failed bearing.”

The serious incident occurred as a consequence of an intermediate gearbox input bearing failure. The failure caused the intermediate gearbox input bearing housing to overheat, and fracture.

As a consequence of the serious incident and the previous remarks with repeatedly chip warnings, the operator's maintenance organization removed the affected intermediate gear box Part Number S6135-66300-002 from their component maintenance capability list.
