Havarikommisionen
Accident Investigation Board Denmark

BULLETIN

Serious incident

LN-BRE

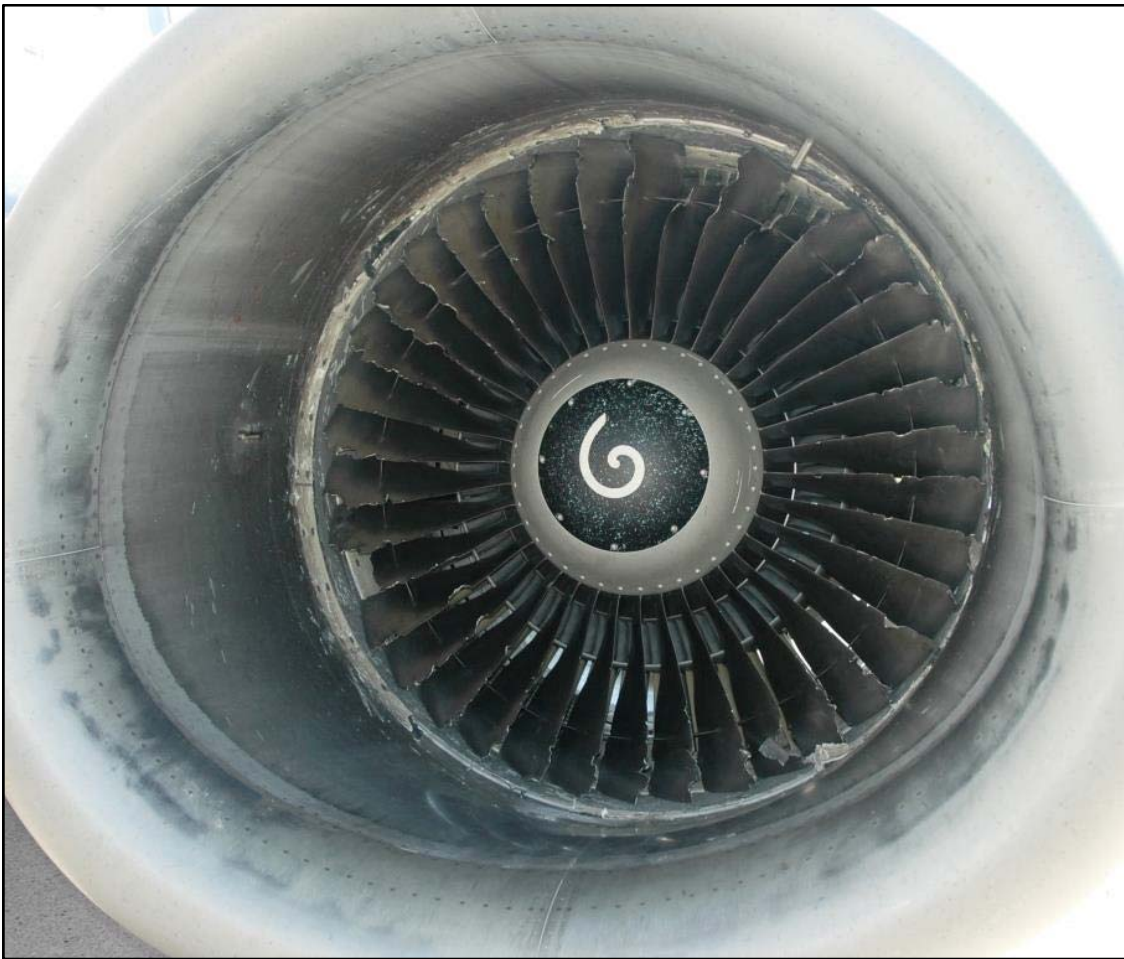
The engine air intake duct and the engine fan were damaged.

All the engine fan blades were damaged and bended as seen in the pictures below.

Three fan blade tips were missing. Two of these three fan blade tips were found in the duct.

The abnormal vibrations were caused by imbalance of the damaged fan disc.

The engine was replaced.

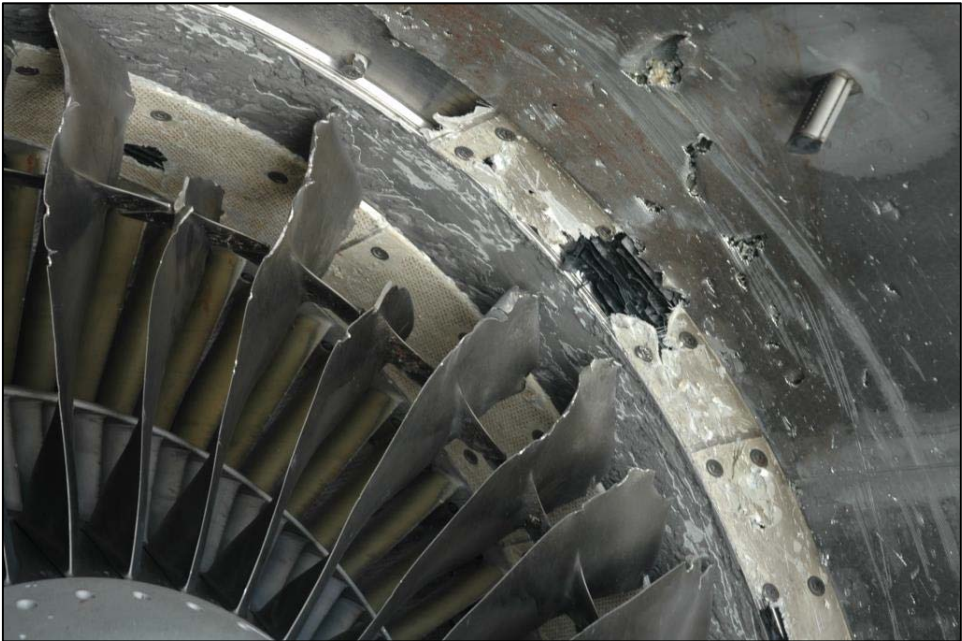
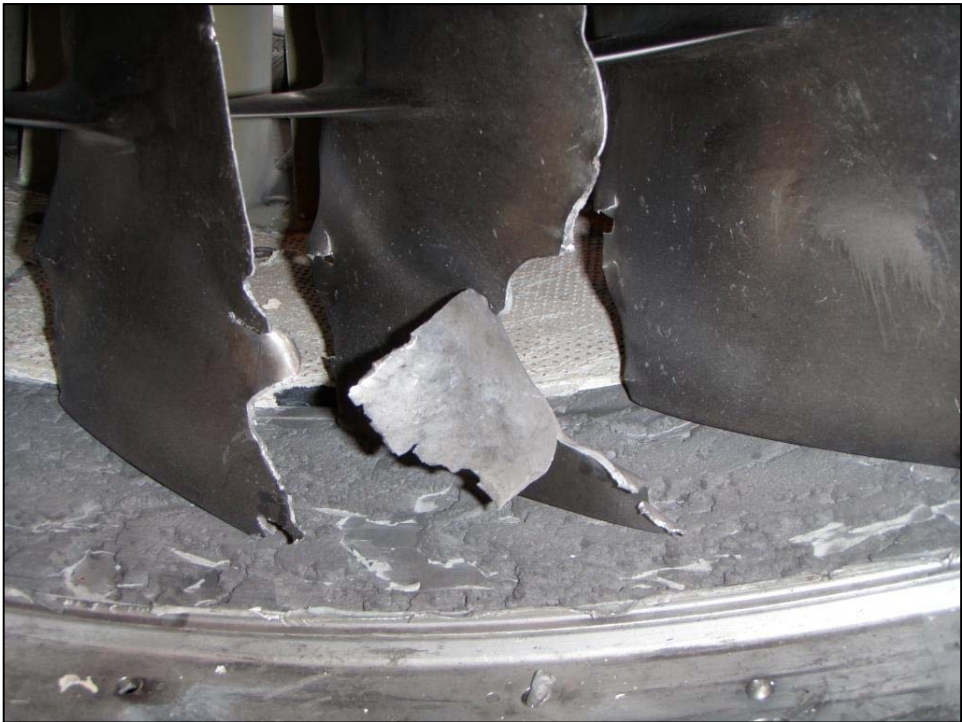
At the front side of the fan the air intake duct broke up at several places. There was a track of damage all around the duct following the counter clockwise rotation of the fan (pictures below).

The left air intake duct and the engine fan were significantly damaged.

The AIB DK considers the broken fan blade tips – during rotation – as causal factor to the air intake duct damage.
