Avoidable Accidents No. 6

Experience won't always save you

Pilot experience is not always a protection against an accident

Research AR-2012-035

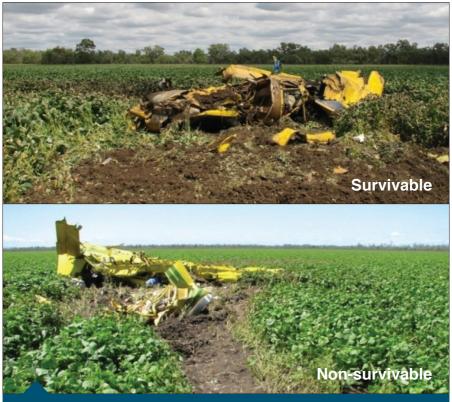
The two aircraft as they came to rest in adjoining fields

Although visibility at the time of the accident was reported as 'good', neither pilot had seen the other aircraft in sufficient time to avoid a collision. Agricultural pilots engaged in aerial application a few metres above the ground have no opportunity to visually scan for conflicting traffic. Even during procedure turns, where the aircraft is at 200 to 300 ft above ground level, pilots are concentrating on accurately aligning the aircraft for the next swath run and are not looking around for other aircraft. Basically, they rely on pilots of other aircraft to remain clear of their application area during aerial spraying operations.

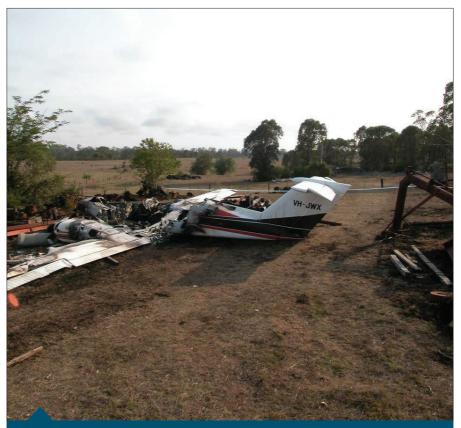
The investigation determined that the simulated engine failure was conducted from a height where it was not possible to ensure a safe flight path, because visual reference with obstructions could not be achieved. In darkness there was insufficient illumination to see and avoid obstructions. By the time the ATO restored full power to the other engine, the aircraft had diverged from the runway centreline and it was too low to avoid a collision with a tree that was well outside the obstacle clearance surface for that runway.

The investigation found that simulated engine failure at night at low-level was contrary to the pre-flight briefing given by the ATO and was also contrary to the *Aeronautical Information Publication* that provided guidance recommending against low-level asymmetric operations at night. That safety advice resulted from a number of previous fatal accidents that occurred during low-level, asymmetric, night training.

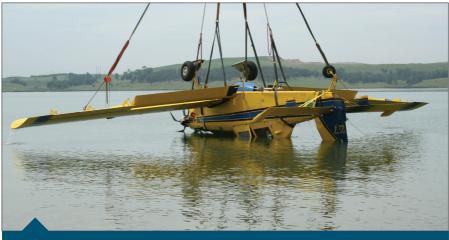
The investigation concluded that the right experimental ski breached the surface of the water which caused a substantial amount of drag to act on the right side of the aircraft, and as a consequence, it became uncontrollable.

The damaged aircraft during recovery from the lake

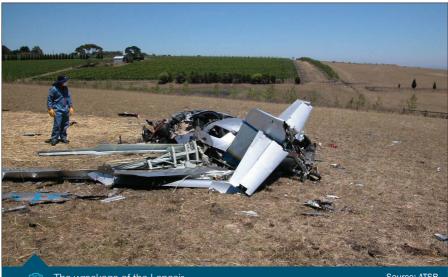
Recorded flight data from recording devices aboard the aircraft indicated that the aircraft had entered a stall at an altitude of 6,200 ft and rolled at the initiation of the stall. It continued to roll as it descended rapidly, accelerating to approximately 150 kts and descended at an angle of approximately 40 degrees from the horizontal, with low engine power that increased shortly before the aircraft impacted the ground.

The wreckage of the Lancair

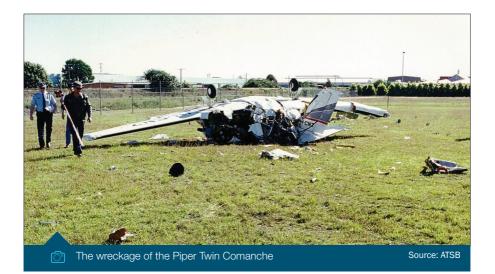
The aircraft had impacted the ground inverted and rolling to the left. Ground contact marks and the condition of the propeller blades indicated that the right engine was developing significant power at impact while the left propeller was rotating at impact but that the engine was not developing power. The landing gear was locked in the extended position and the wing flaps were fully retracted - the takeoff configuration. There was no evidence of fire in the left engine.

While an unsecured fuel cap should have been detected and secured before flight, failure to do so should not have led to an accident with such tragic consequences. The investigation was unable to determine which pilot had been flying the aircraft but regardless of that fact, either pilot should have been able to handle the situation. The loss of fuel from an unsecured fuel cap did not represent an impending emergency, and required the pilot flying to either immediately reject the takeoff or continue the takeoff and climb to a safe height and speed. In any event, there was nearly 800 m of runway and overrun ahead on which to land before the aerodrome boundary.
