Havarikommisjonen
Accident Investigation Board Denmark

Bulletin 2022-117

Accident to N745AJ (Cirrus SR22) 3.8 nm south of Ringsted (EKRS) on 20-3-2022.

ISSUED JULY 2023

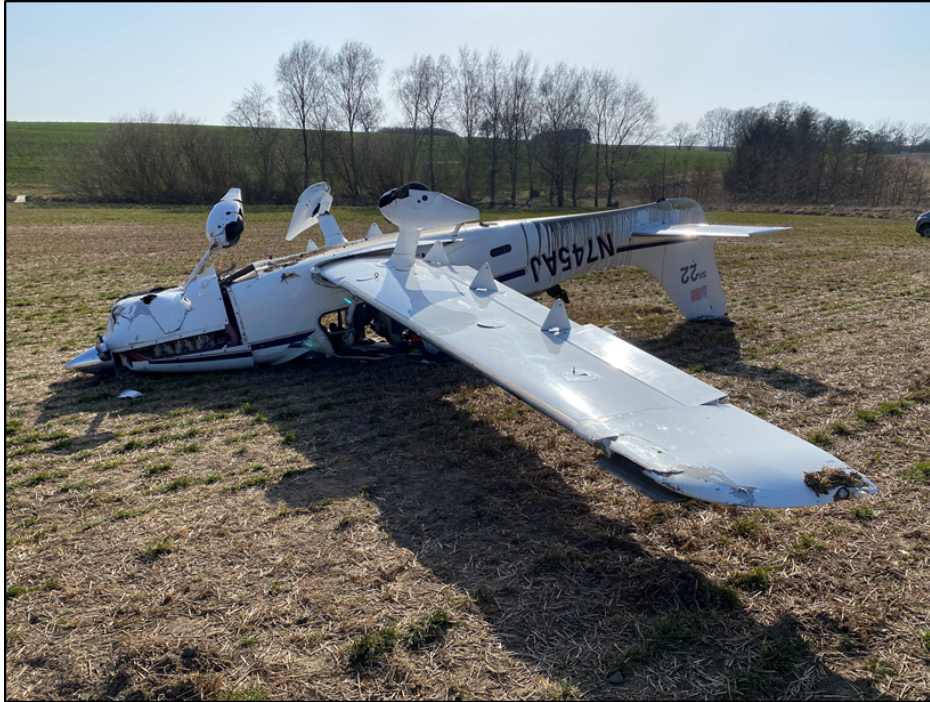
The ground impact and the consequential damages destroyed the aircraft.

Photo 1. The destroyed aircraft in an upside down position on the accident site.

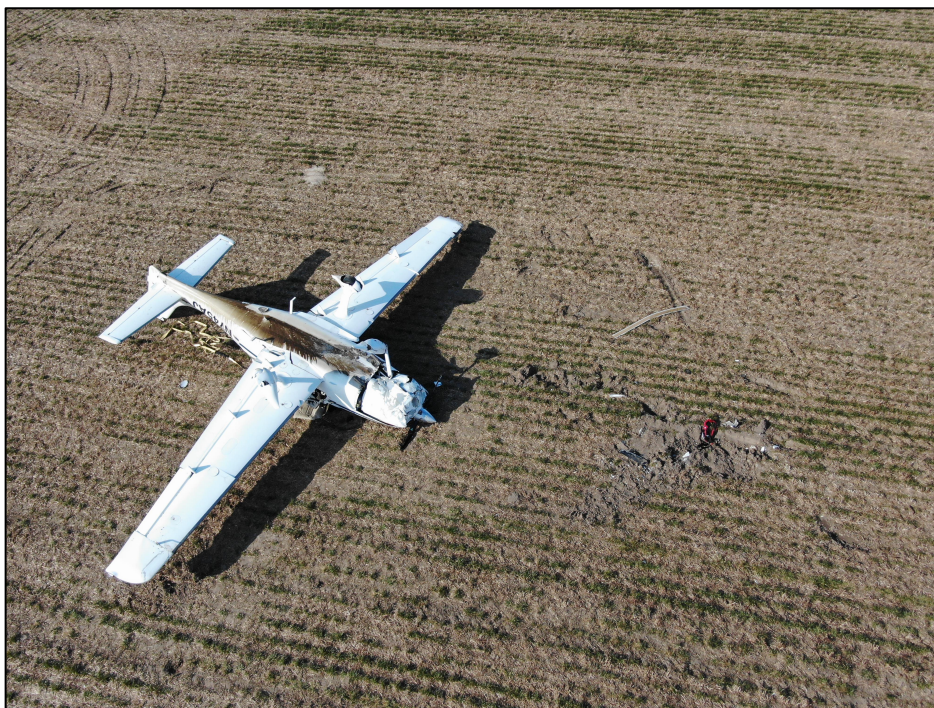
Photo 2. A drone photo of the accident site.

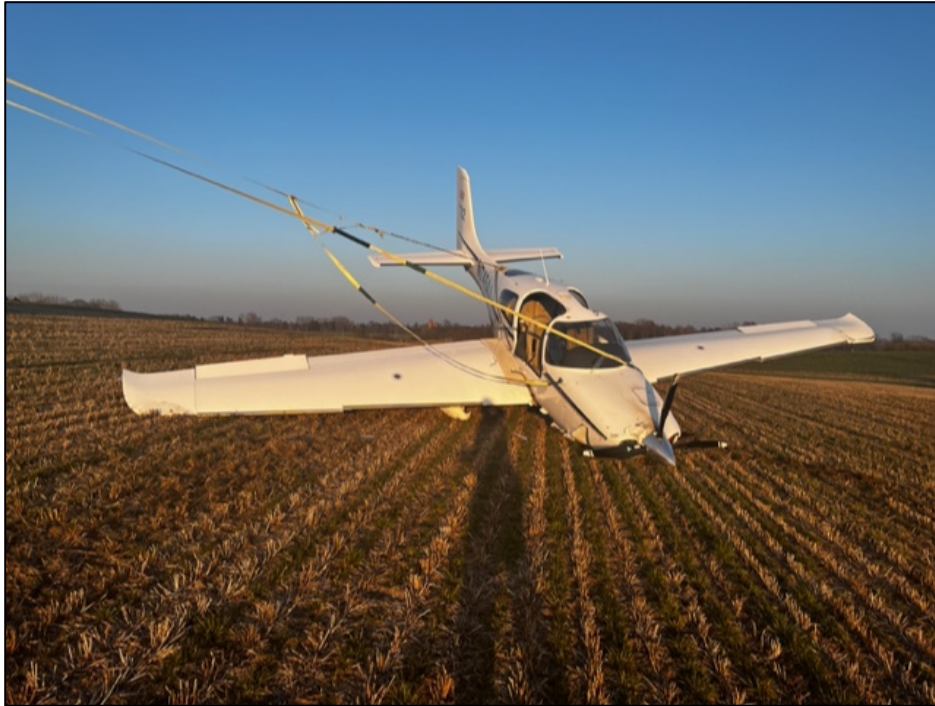
The aircraft impacted ground on its nose landing gear and then on the main landing gear. The nose landing gear collapsed, and the nose section and the propeller hit the ground.

Photo 18. The aircraft in an upright position shortly after ground impact.

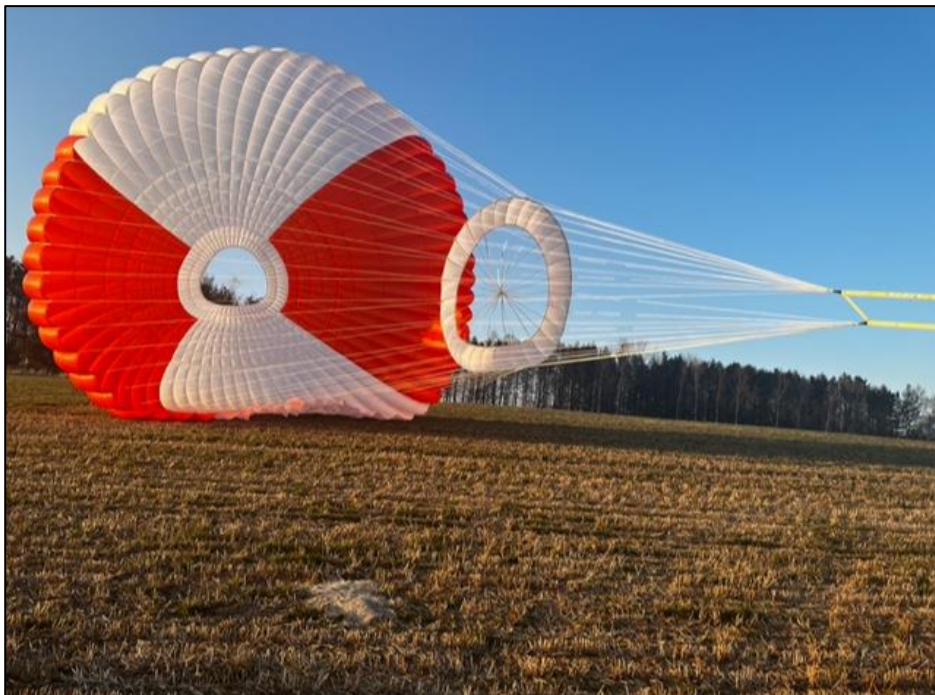
Photo 19. A fully deployed parachute shortly after ground impact.

When witnesses arrived, the parachute still was in the air and attached to the aircraft. Because of strong wind, the parachute drifted from one side to the other. The wind caught the parachute and rotated the aircraft over the propeller and the right hand wing, and the aircraft came to rest in an upside down position approximately 6 m downwind of the ground impact area. A minor fuel leakage from the left wing fuel tank caused fuel spill on the ground.

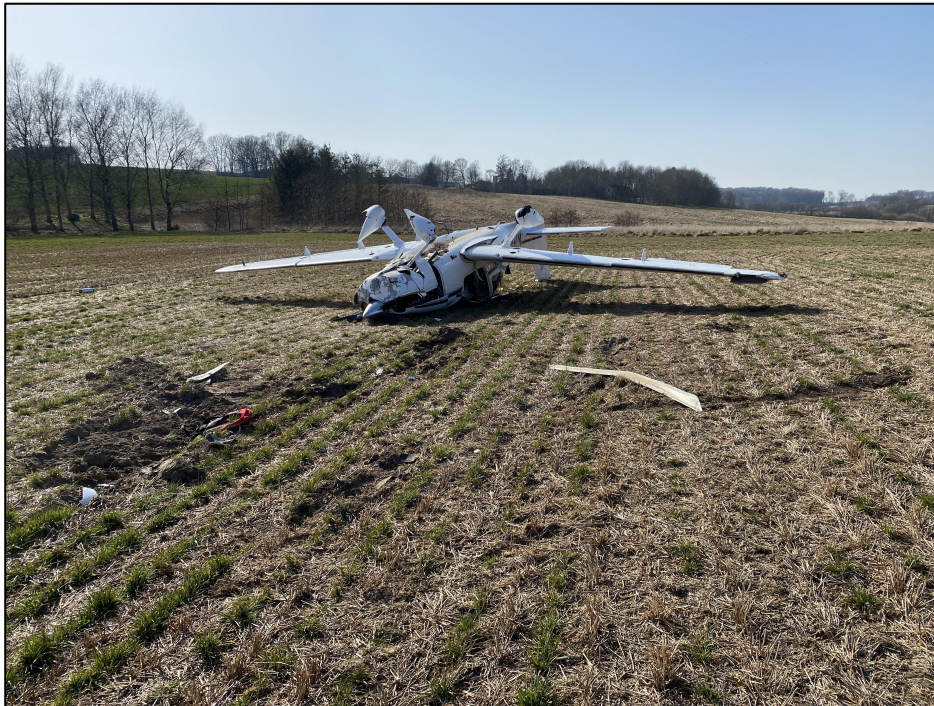
Photo 20. The aircraft in an upside down position without parachute and parachute harness.

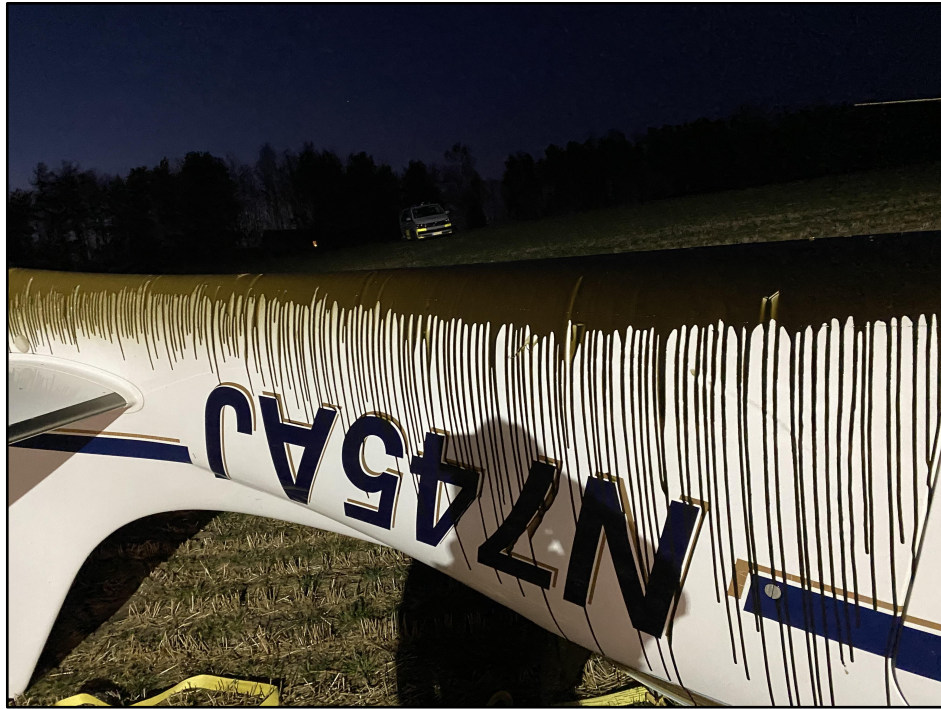
- c. Onsite investigation.
 - The aircraft was in an upside down position.
 - Engine oil soaked the underside of the aircraft fuselage from the firewall down to the tail section.
 - The ELT switch was in the armed position.
 - The master switch was in the OFF position.
 - The fuel tank selector handle was in the left hand tank position.
 - The mixture control setting was rich.
 - The throttle handle was in the idle position.
 - The ignition was OFF.
 - The release knob on top of the fuel selector handle was missing.
 - The fuel boost pump switch was in the OFF position.

Photo 21. Engine oil on the underside of the aircraft fuselage.

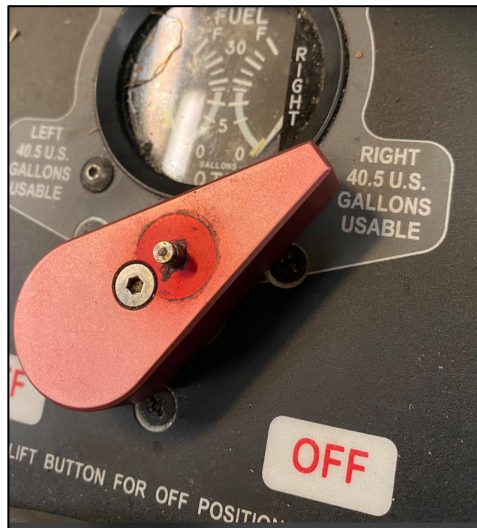
Photo 22. The release knob on top of the fuel selector handle was missing.

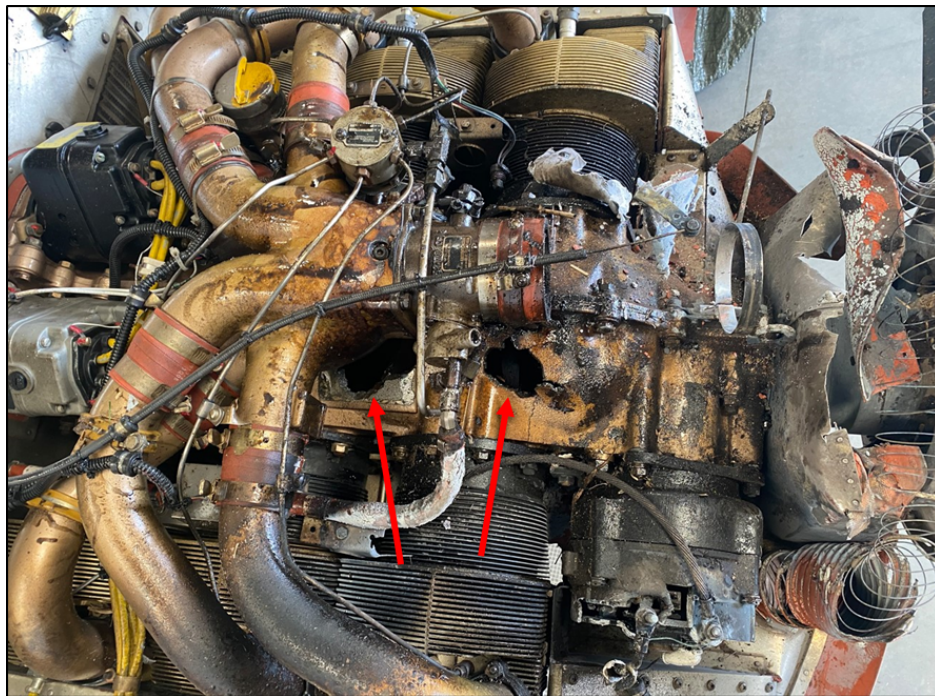
- There was fire damage to the forward area of the engine top cowling and the upper forward area of the engine.
- There was no fire damage to the lower engine cowling, but the lower engine cowling had several cracks and fractures.
- Because of fire in flight, there was fire damage to parts of the engine air induction system i.e. filter and flexible tubes and part of the alternator.
- The engine air cooling baffling installation and seals were intact.
- There were three holes in the upper area of the engine crankcase.
- Removal of the engine with the propeller did not reveal any other abnormalities.

Figure 1. Top view of the engine with two holes in the crankcase and fire damage. Two red arrows mark the crankcase holes.

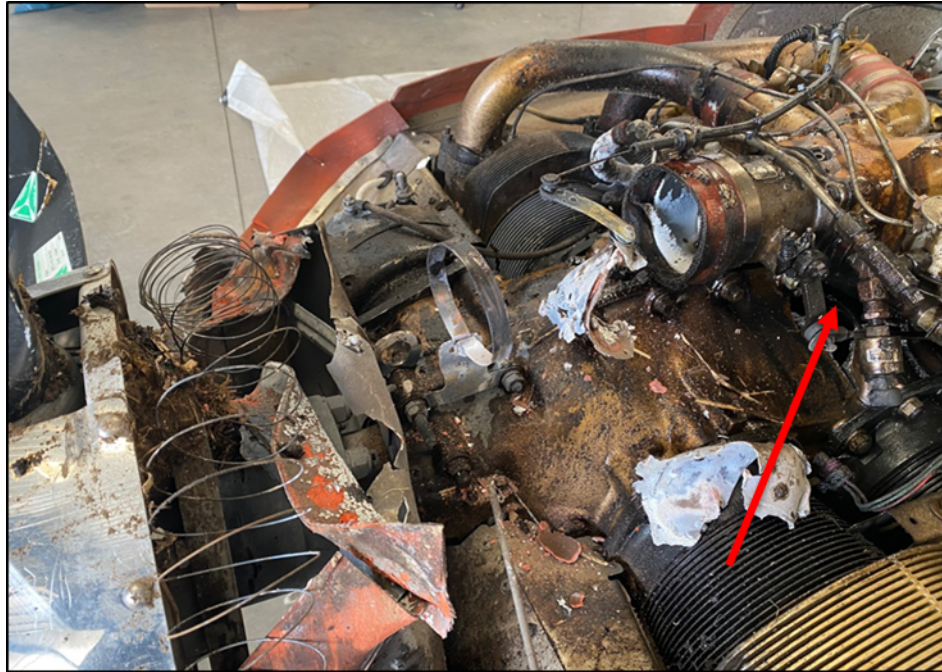
Figure 2. Top view of the engine with a hole in the crankcase under the air throttle body and fire damage. A red arrow mark the crankcase hole.

- internal engine parts penetrating the crankcase caused a hole at the lower face of the air throttle body.
- one spark plug in each of the cylinders no. 1 and 2 had parts of the centre electrode insulator loose or missing.

4. At 16:27:36 hrs, the engine oil pressure started decreasing rapidly from 42 psi, probably because of a high engine crankcase pressure pressing out the engine oil from the sump through the oil breather tube connected to the oil filler pipe.
5. At 16:30:30 hrs, the engine oil pressure decreased to 10 psi and still decreased (minimum oil pressure required for engine operation).
6. In the period from 16:32:00 hrs to 16:32:12 hrs, the engine oil pressure decreased to 5 psi and simultaneously, the rpm decreased to 2,080 rpm. The MP decreased to 17.4. Because of severe heat damages caused by lack of bearing lubrication, the connection rod at cylinder no. 4 disconnected from the crankshaft. The loose connecting rod penetrated the engine crankcase, hit, and penetrated the air throttle body leading to reduced rpm.

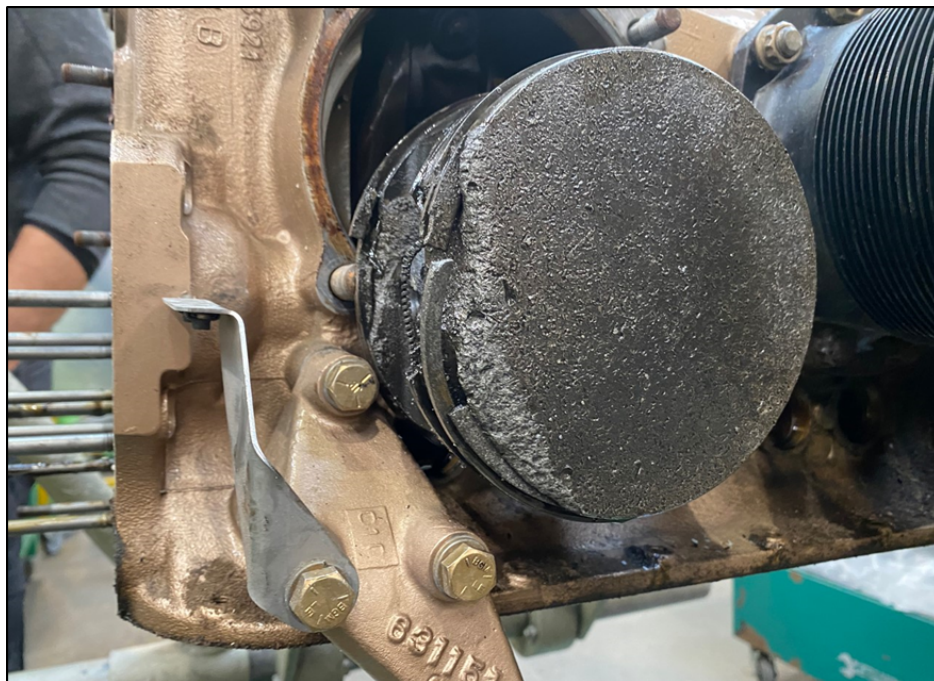
- the piston of cylinder no. 1 had severe damages. Approximately 30% of the circumference of the piston had severe corner and edge damages with missing material. There were damages to the first and second compression ring, the oil control ring and the scraper ring including one end of the piston pin. The top surface of the piston had many small damages in form of indentations/pitting marks (detonation characteristics.).

Photo 24. Cylinder no. 1 piston damage with detonation characteristics.

1. From 16:09:18 hrs until 16:11:30 hrs (2 minutes and 12 seconds during climb), the CHT of cylinder no.1 was above 420° F causing detonation and consequential damages (surface indentations and corner melting) to the piston of cylinder no. 1.
2. At 16:24:18 hrs at cruise level (FL 080), the CHT of cylinder no. 1 reached 398°F and still increased.
3. At 16:24:36 hrs, the CHT of cylinder no. 1 peaked at 404° F. Simultaneously, the EGT of cylinder no. 1 decreased from 1275° F to 975° F, and the engine rpm started fluctuating. Shortly after, the EGT and CHT of cylinder no. 1 started decreasing rapidly. At that point, severe damages occurred to the edge and side of the piston including the compression rings, and the oil control and scraper rings (induced earlier during detonation).

The side damages to the piston of cylinder no. 1, with the engine still running, led to increasing engine crankcase pressure.
