Havarikommisjonen
Accident Investigation Board Denmark

Statement 2023-412

Accident to N9902V (Cessna 180 H) in Lolland Falster Maribo (EKMB) on 5-8-2023.

ISSUED SEPTEMBER 2023

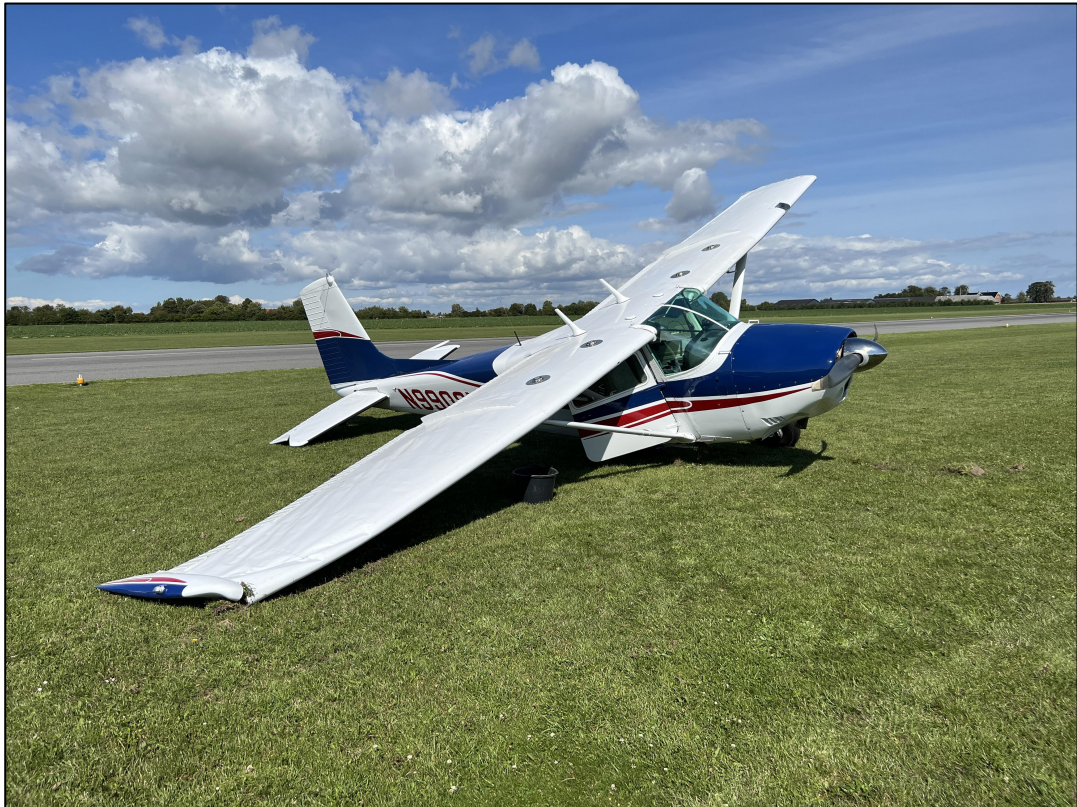
During the landing roll on runway 27, the pilot experienced a sudden wind gust, and the aircraft uncontrollably veered to the left and ran off the left side of the runway into the safety zone.

In the safety zone, the right main landing gear collapsed, and the right wing tip hit the ground.

The right main landing gear collapse in the safety zone led to substantial damages to the aircraft.

Figure 1. The aircraft with substantial damages in the safety zone south of runway 27.
