**Havarikommisjonen**  
Accident Investigation Board Denmark

**Bulletin 2023-339**

**Accident to N44WN (Daher TBM 900) in Narsarsuaq (BGBW) on 17-6-2023.**

**ISSUED OCTOBER 2023**

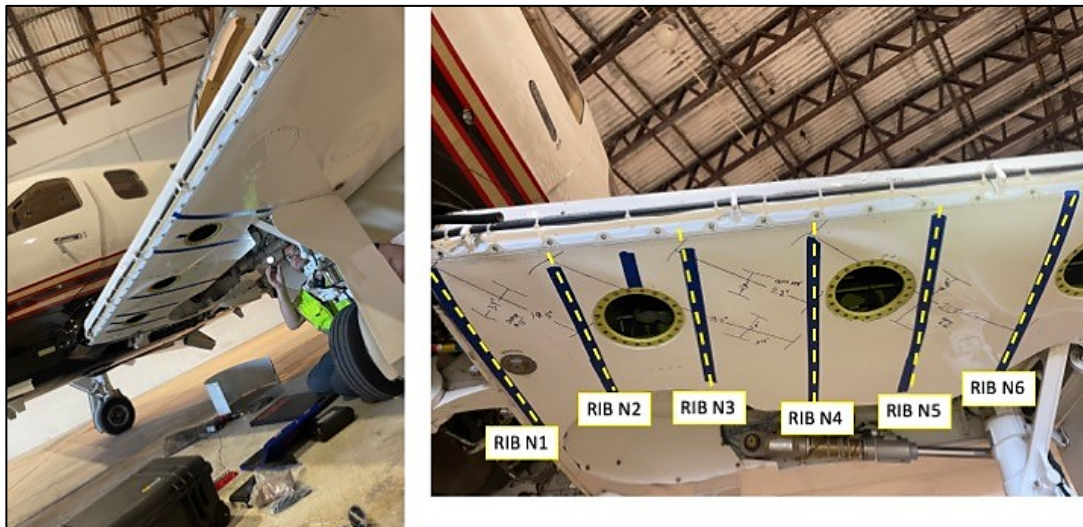
The accident led to substantial damages to the left hand wing structure.

- The left hand wing inboard lower skin had multiple areas of deformation between ribs N1-N8 (damages no. 1, 2, 3, and 4).
- The left hand wing rib N5 forward and aft sections were deformed (damage no. 8).
- The forward section of rib N5 was damaged from skin deformation at damage no. 4 and had sheared rivets heads causing a fuel leakage.
- The left hand wing inboard leading edge spar had deformations (damages no. 5, 6, and 7).

Figure 1. Damages to the left hand wing structure.

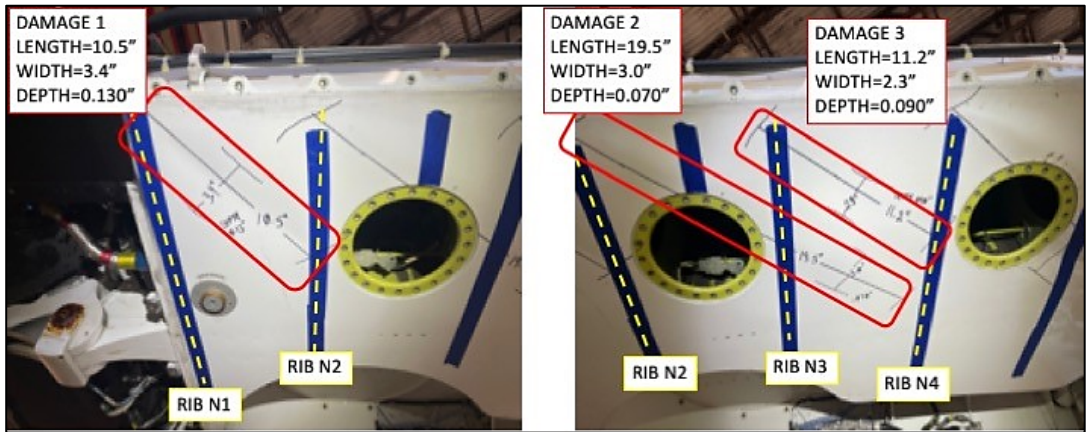
Figure 2. Damages to the left hand wing structure.

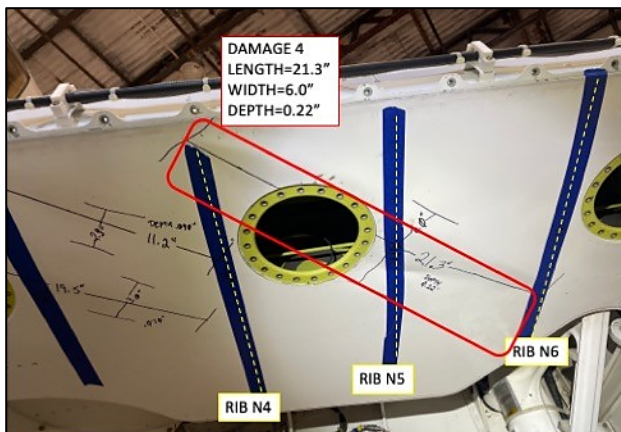
Figure 3. Damages to the left hand wing structure.

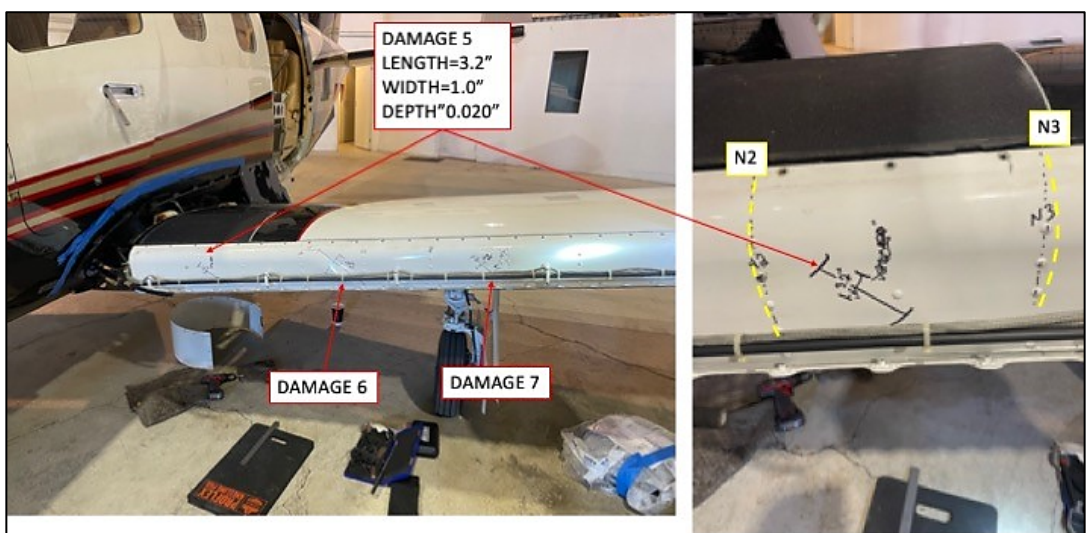
Figure 4. Damages to the left hand wing structure.

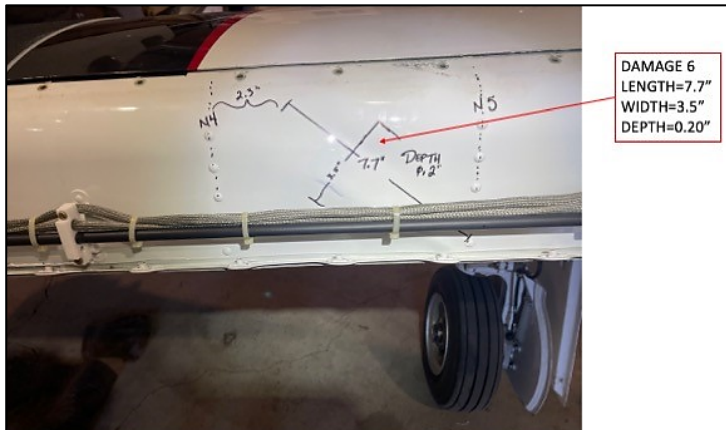
Figure 5. Damages to the left hand wing structure.

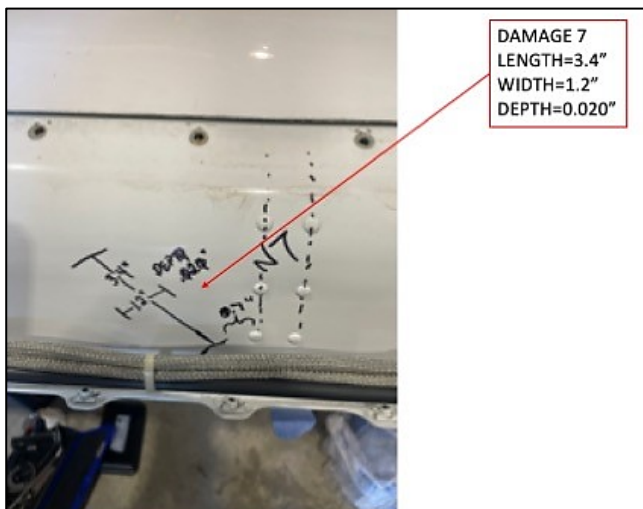
Figure 6. Damages to the left hand wing structure.

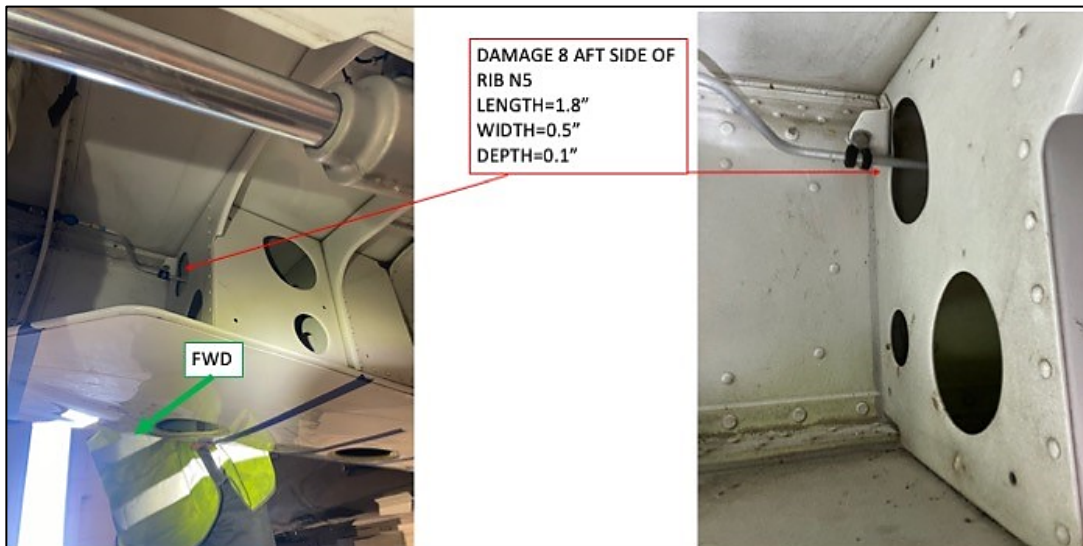
Figure 7. Damages to the left hand wing structure.

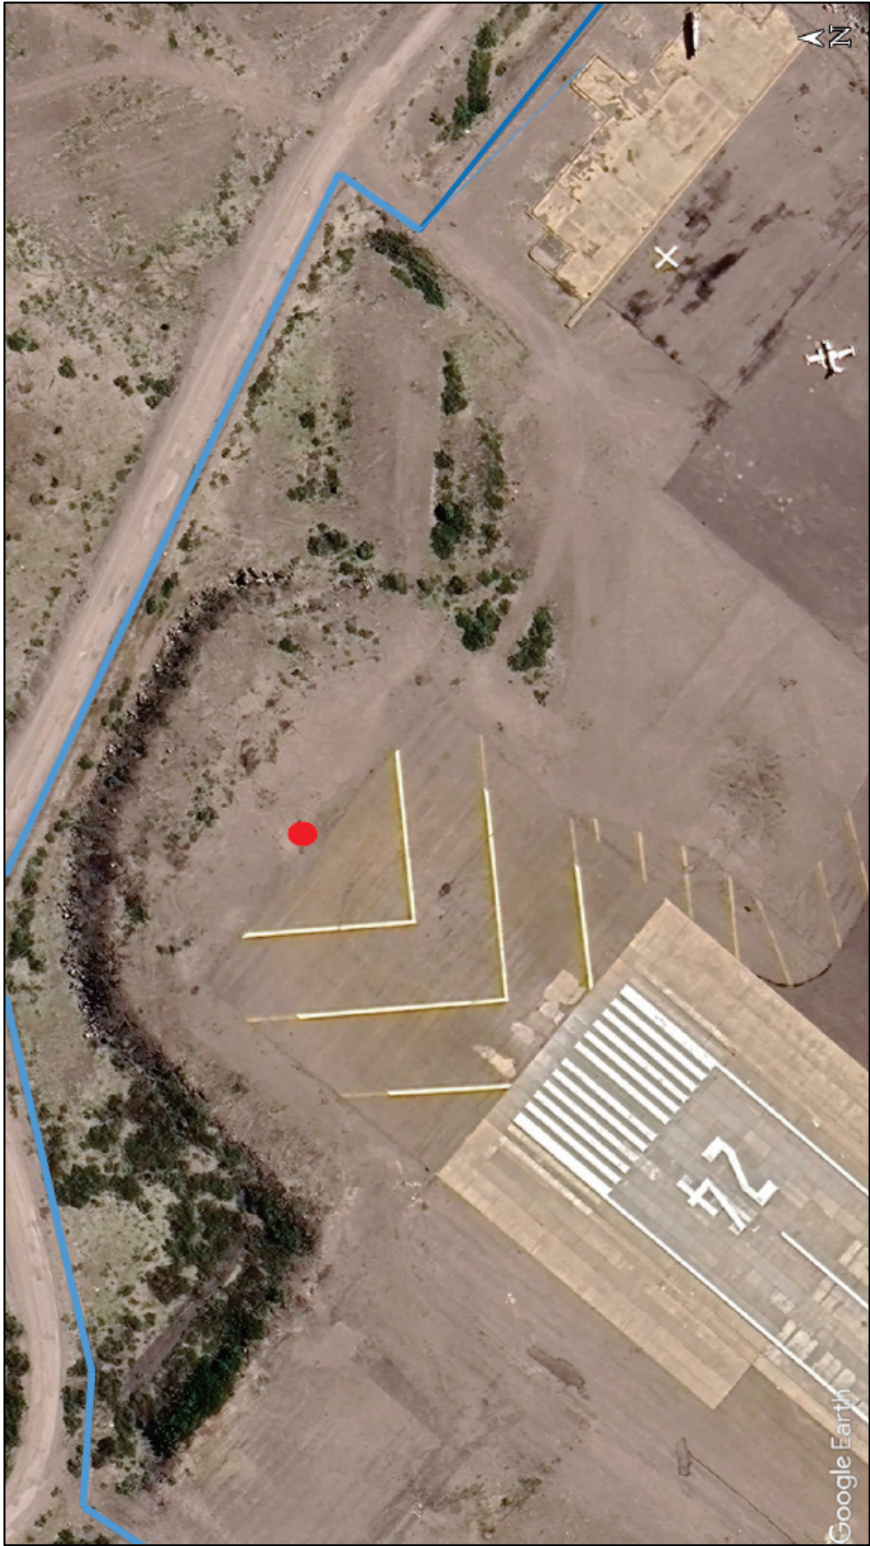
**APPENDIX 7**

This inspection revealed main wheel tracks 81 m northeast of the threshold lights to runway 24.

The main wheel tracks area consisted of gravel, rocks, and low vegetation.

Note. The red circle represents the position of the accident site.

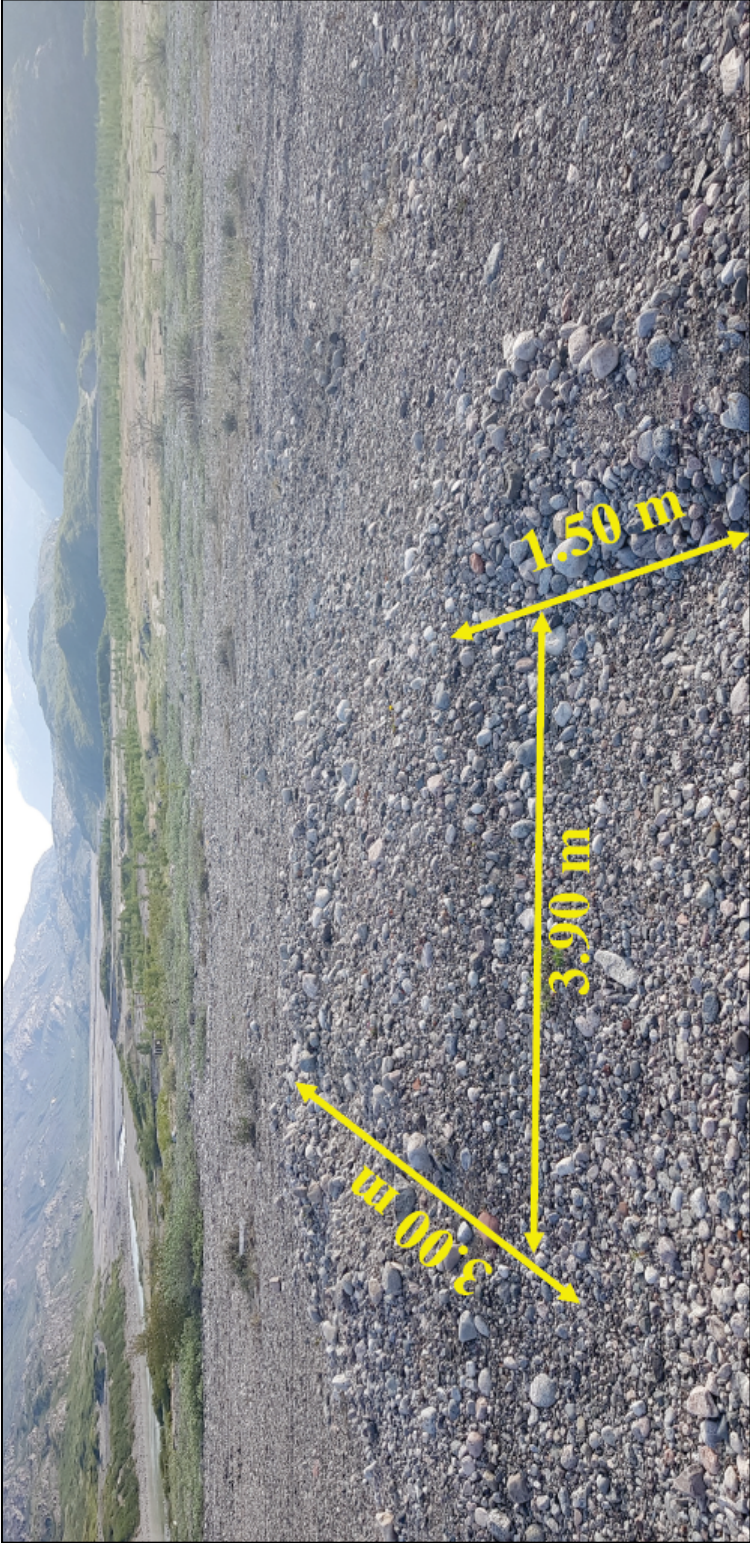
**APPENDIX 8**

The main wheel tracks (a distance of 3.90 m between the main wheels) were consistent with the POH presented distance between the main wheels (3.874 m).
