Havarikommissionen

Report 2022-150

Serious incident to CS-TNV (Airbus A320-214) in Copenhagen/Kastrup (EKCH) on 8-4-2022

ISSUED FEBRUARY 2024

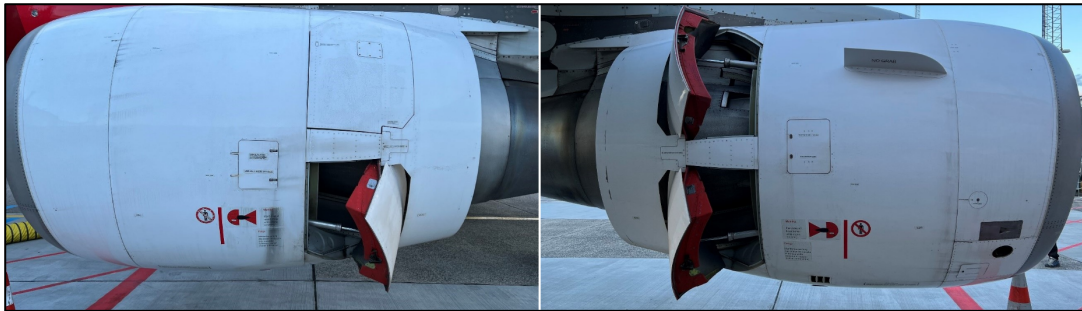
Figure 15. Engine #1 seen from the LH and RH side

The initial inspection on the aircraft stand revealed that engine #1 LH upper blocker door PDL was unlocked, but the actuator secondary lock remained locked i.e. the LH upper blocker door could not be moved to full deployment. The remaining three blocker doors were all fully deployed.

Visual inspections revealed only one small defect on the LH upper door latch roller which was seized. Functional tests of the thrust reverser system with and without engine running showed normal behaviour and no faults.

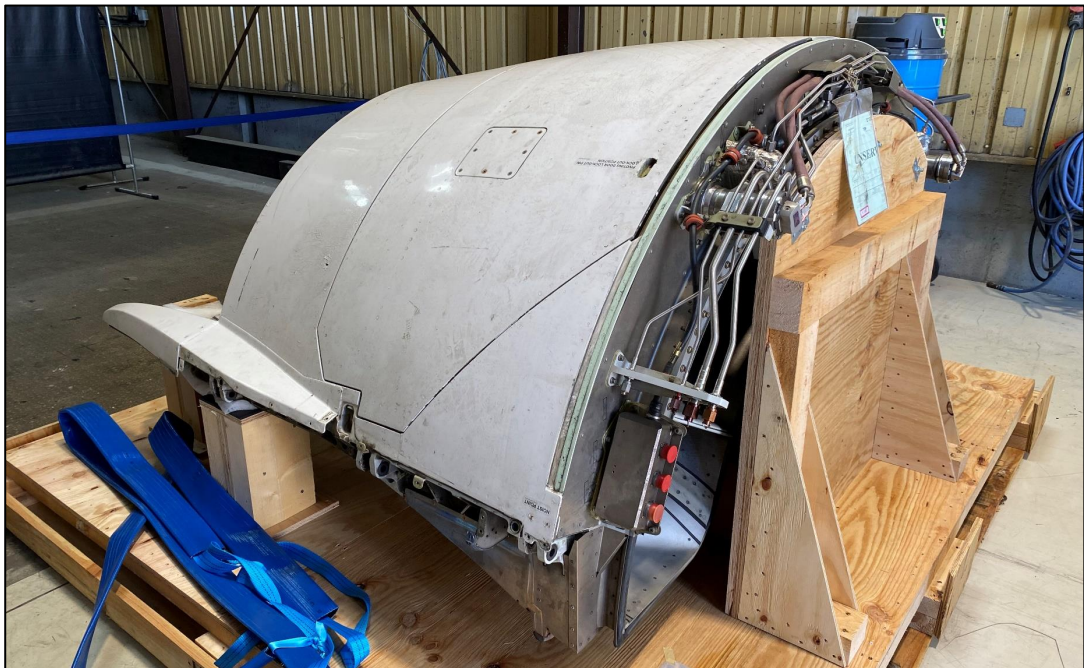
Figure 16. Engine #1 thrust reverser LH D-duct

Under supervision of the AIB, the BEA, the operator and the aircraft manufacturer, the OEM inspected engine #1 thrust reverser D-ducts at an OEM maintenance facility in France. The inspections revealed only minor defects. The conclusion was that none of these defects could have contributed to the thrust reverser not stowing.

Friction in the blocker door hinges was checked without the actuators installed. Friction was found to be very low. All four blocker doors moved freely.

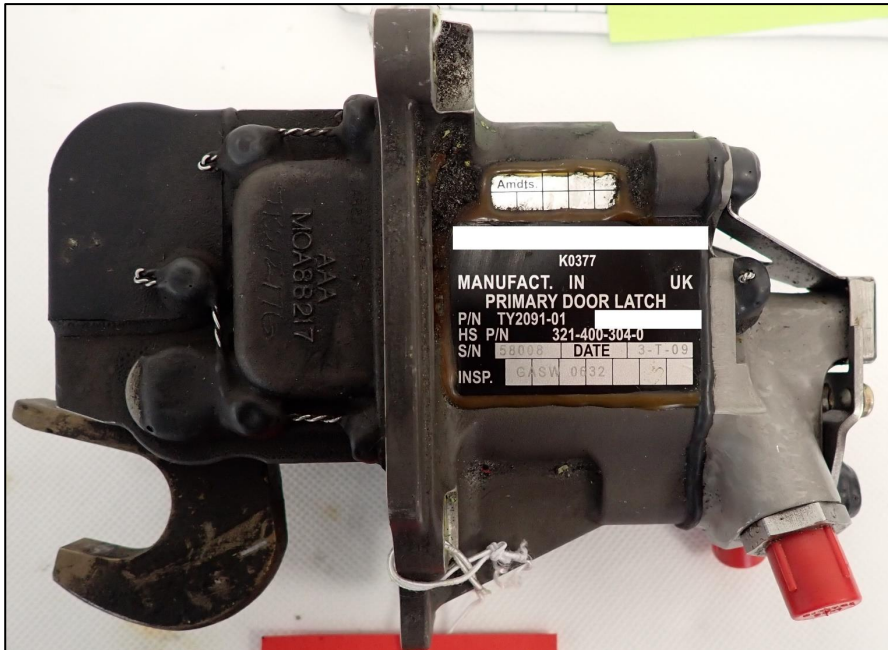
Figure 17. A PDL in as received condition

The detailed inspection of the HCU, PDLs and actuators revealed only minor defects, and the OEM concluded that none of the defects could have contributed to a degradation of performance of the thrust reverser system resulting in an inability to stow.

The subject PDL was replaced. A workshop inspected the PDL and found it in dirty condition with only a small amount of remaining grease. The PDL passed the CMM test.

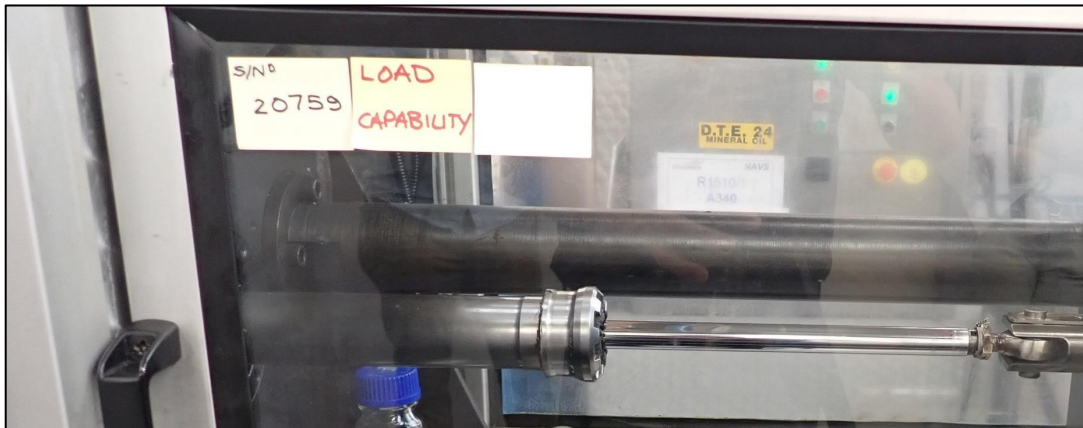
Figure 21. Actuator load capability testing

All tests confirmed that the actuators were able to stow when subjected to the event load with approximately 50 % additional load capability.

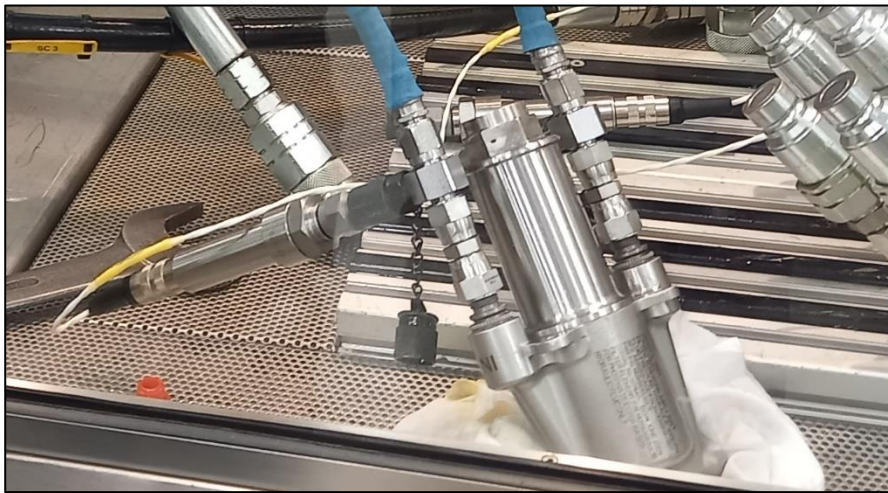
Figure 23. Filter housing test at the operator

The filter housing flow differential pressure test was slightly out of limit, and the shut off valve leak check failed. The operator informed that it had been a challenge in the past to test other filter housings within the CMM limit for the flow differential pressure test.

The leakage of the shut off valve also had no influence on engine #1 thrust reverser's inability to stow.

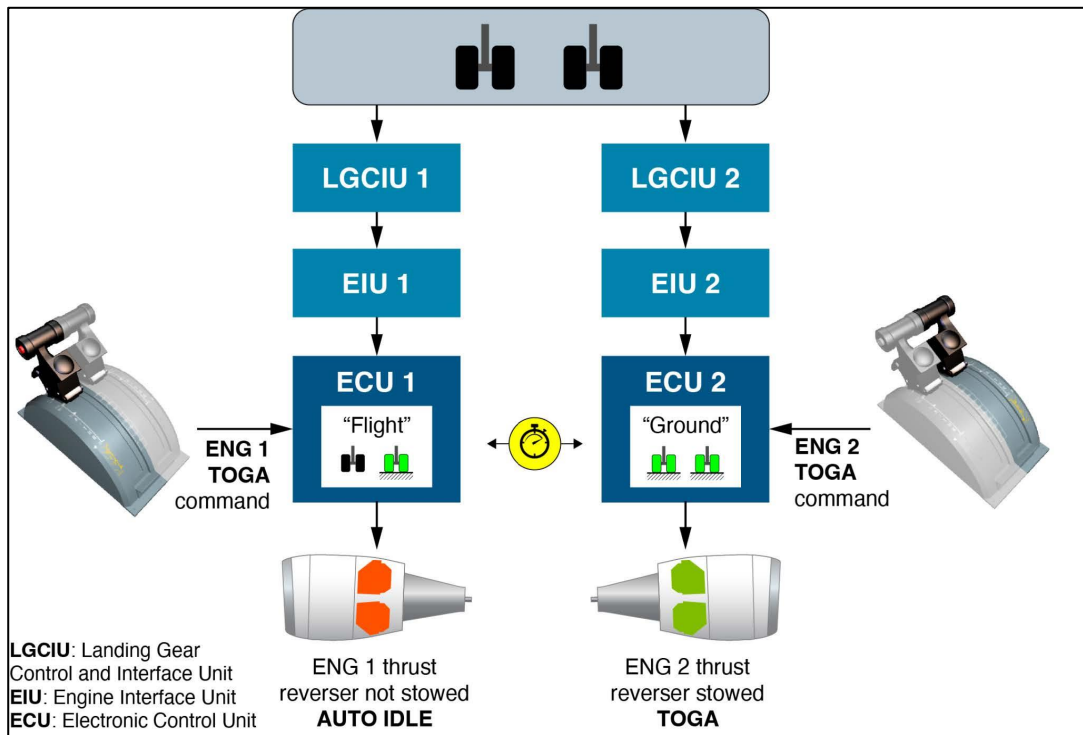
Figure 25. Illustration developed by the aircraft manufacturer to explain the difference in signals to the ECUs

The aircraft manufacturer concluded that due to the input scan and output update frequency combined with the processing time of each computer, ECU #1 received an air signal from the #1 set of computers while sensing the TLA stow signal. At the same time, ECU #2 received a ground signal by the independent #2 set of computers while sensing the TLA forward thrust signal. The opposite scenario was just as likely to have occurred.

To prevent engine thrust reverser(s) not stowing on an A320 family aircraft during an aborted landing after ground contact, the AIB recommends EASA to ensure that the aircraft and engine manufacturer modifies the CFM56-5B ECU software, and that the software modification is mandated and embodied on the entire CFM56-5B fleet when ready for entry into service estimated in 2025.
