# Havarikommissionen

## Report 2022-150

### **Serious incident to CS-TNV (Airbus A320-214) in Copenhagen/Kastrup (EKCH) on 8-4-2022**

ISSUED FEBRUARY 2024

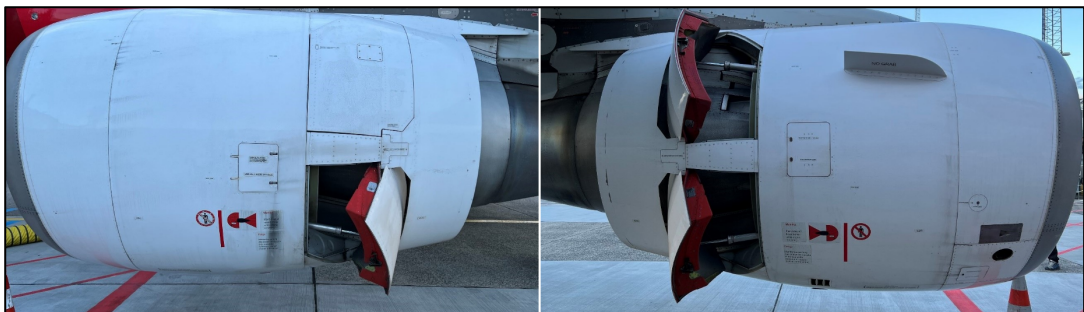
Figure 15. Engine #1 seen from the LH and RH side

The initial inspection on the aircraft stand revealed that engine #1 LH upper blocker door PDL was unlocked, but the actuator secondary lock remained locked i.e. the LH upper blocker door could not be moved to full deployment. The remaining three blocker doors were all fully deployed.

Visual inspections revealed only one small defect on the LH upper door latch roller which was seized. Functional tests of the thrust reverser system with and without engine running showed normal behaviour and no faults.

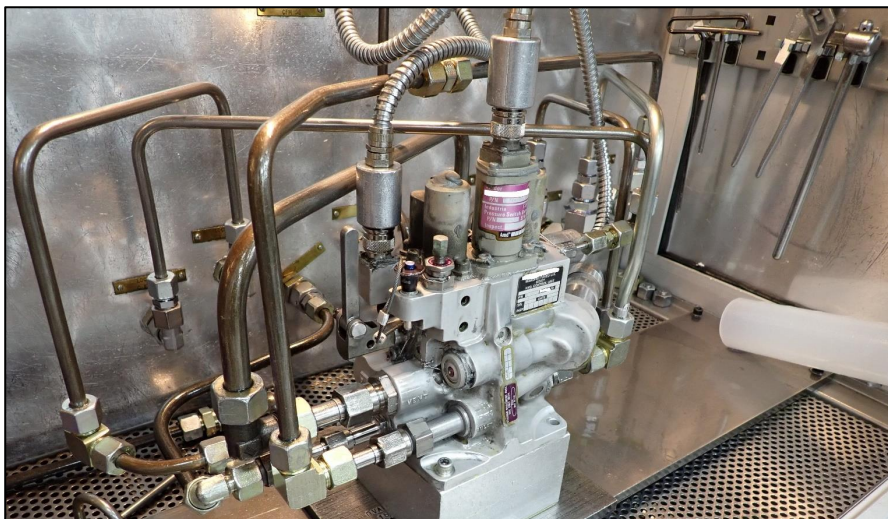
Figure 18. HCU in test rig

In accordance with the respective Component Maintenance Manuals (CMMs), the OEM tested the parts. All parts passed the tests in the CMMs. The test results are presented in the following appendixes:

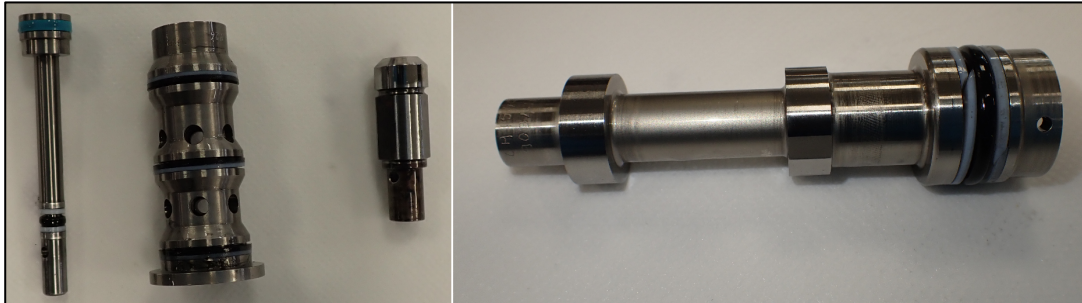
Figure 19. Isolation valve and associated parts shown left, and directional valve shown on the right

To verify that no damage existed on the pressurising valve and the directional valve in the HCU (as this could potentially have resulted in the valves to go periodically stuck), both valves and associated guides and parts were removed and inspected. No defects were found on any of the parts.

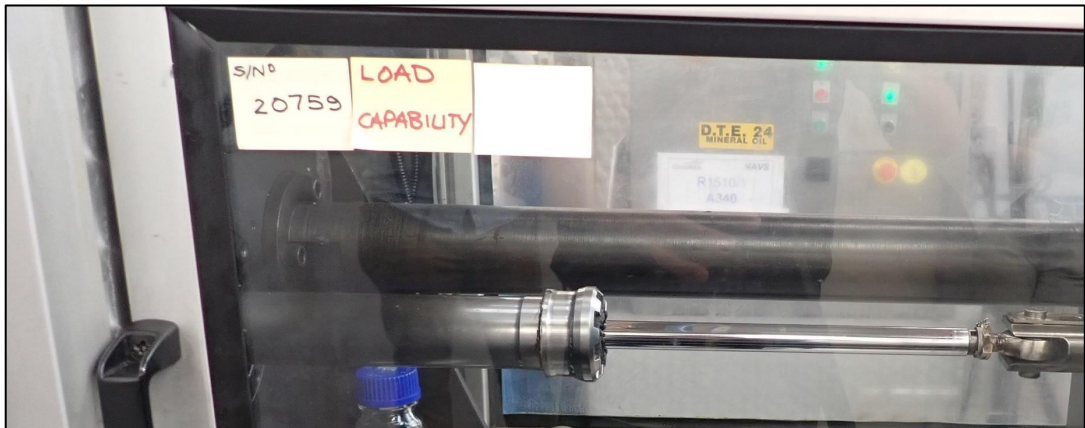
Figure 21. Actuator load capability testing

During the tests, all actuators behaved very similar and produced very similar results:

All tests confirmed that the actuators were able to stow when subjected to the event load with approximately 50 % additional load capability.

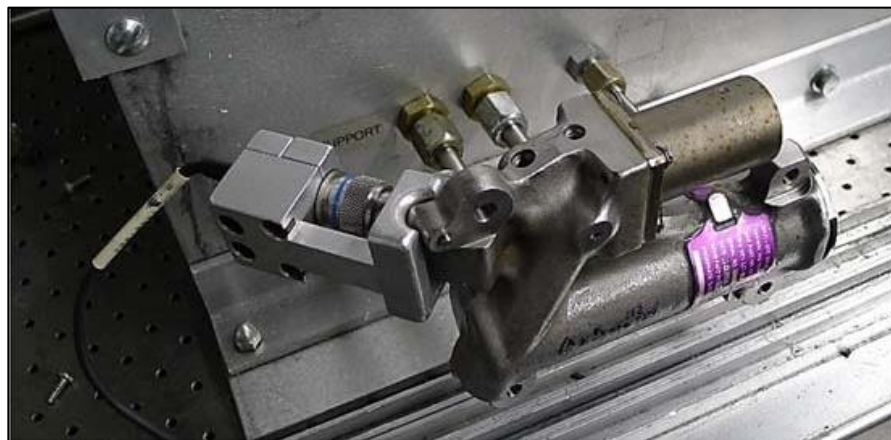
Figure 22. TRSOV in test rig

CMM testing of the component was conducted under the supervision of the NTSB and the FAA. The TRSOV passed all CMM tests.
