BULLETIN

Accident

Partenavia P68B

D-GATA

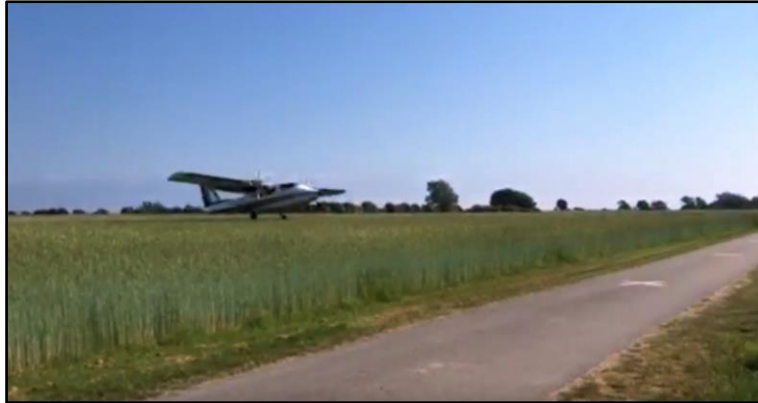
The video recording of the landing sequence revealed:

- The pilot flew a low approach at a shallow angle to runway 29.
- The aircraft was in landing configuration.
- The crops were high.
- On short final, the pilot reduced engine power and initiated the flare by a slight increase of pitch.
- The aircraft flight path remained constant until touchdown.

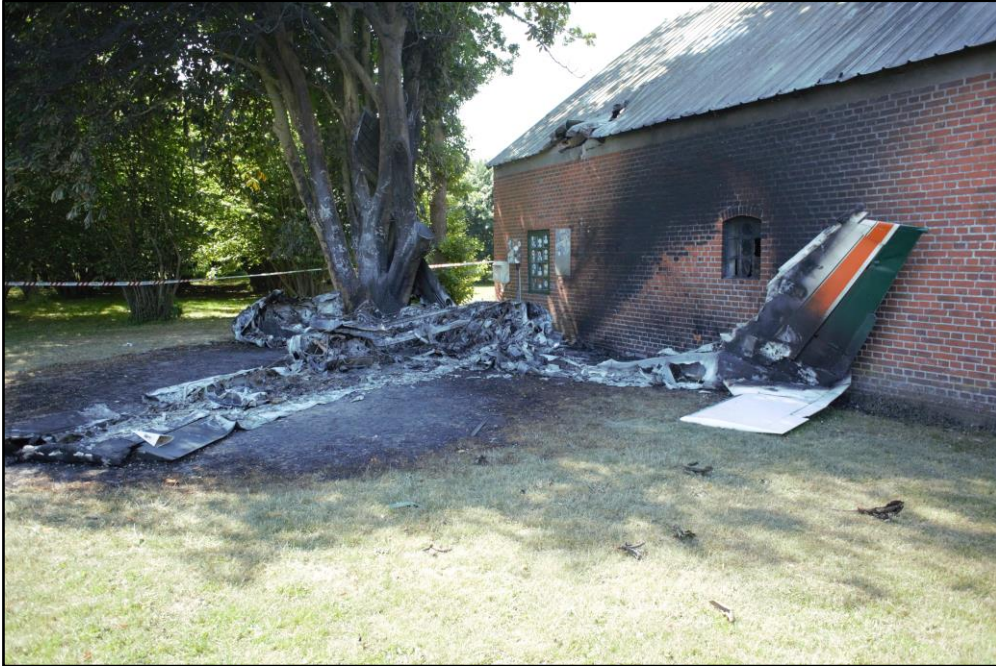
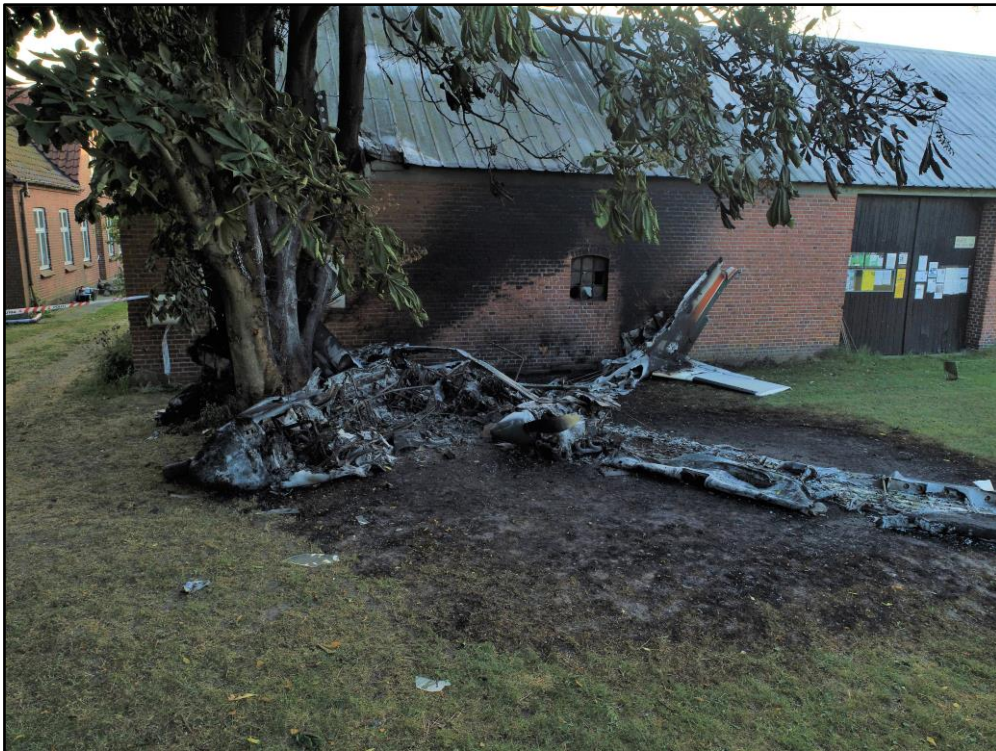
APPENDIX 1

The post-crash fire destroyed the aircraft.

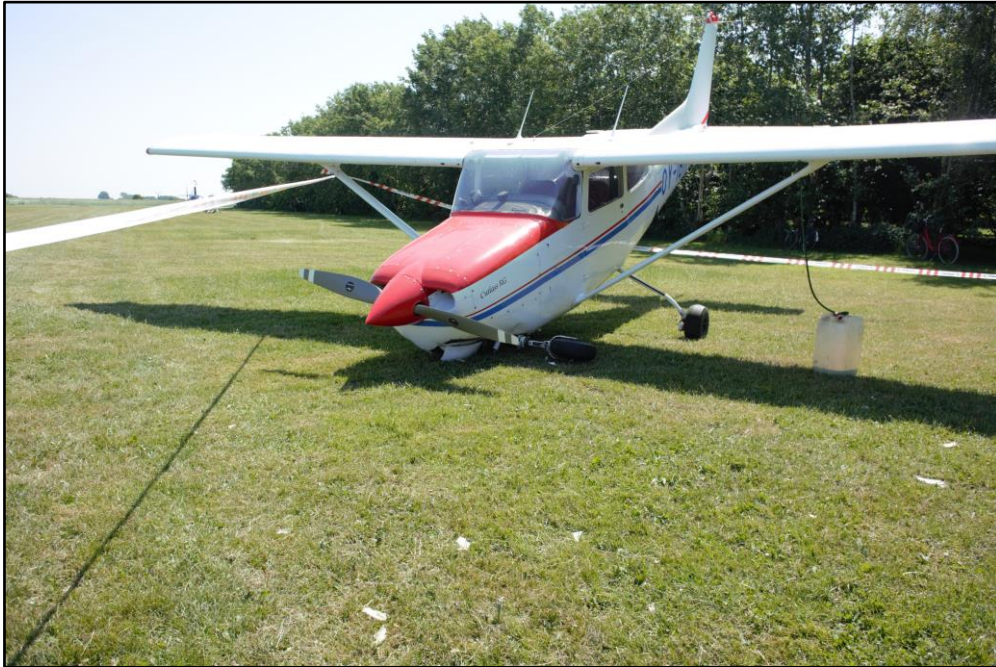
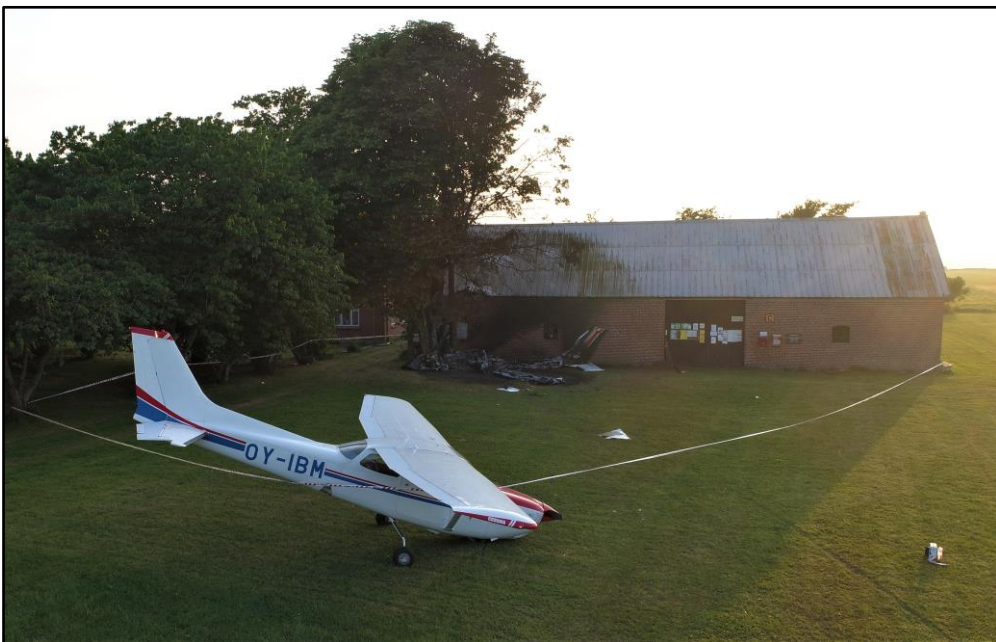
APPENDIX 2

During the sequence of events, the aircraft damaged the nose landing gear and the fuselage of a parked aircraft in the grass parking area.

The post-crash fire damaged a tree and a farm building.

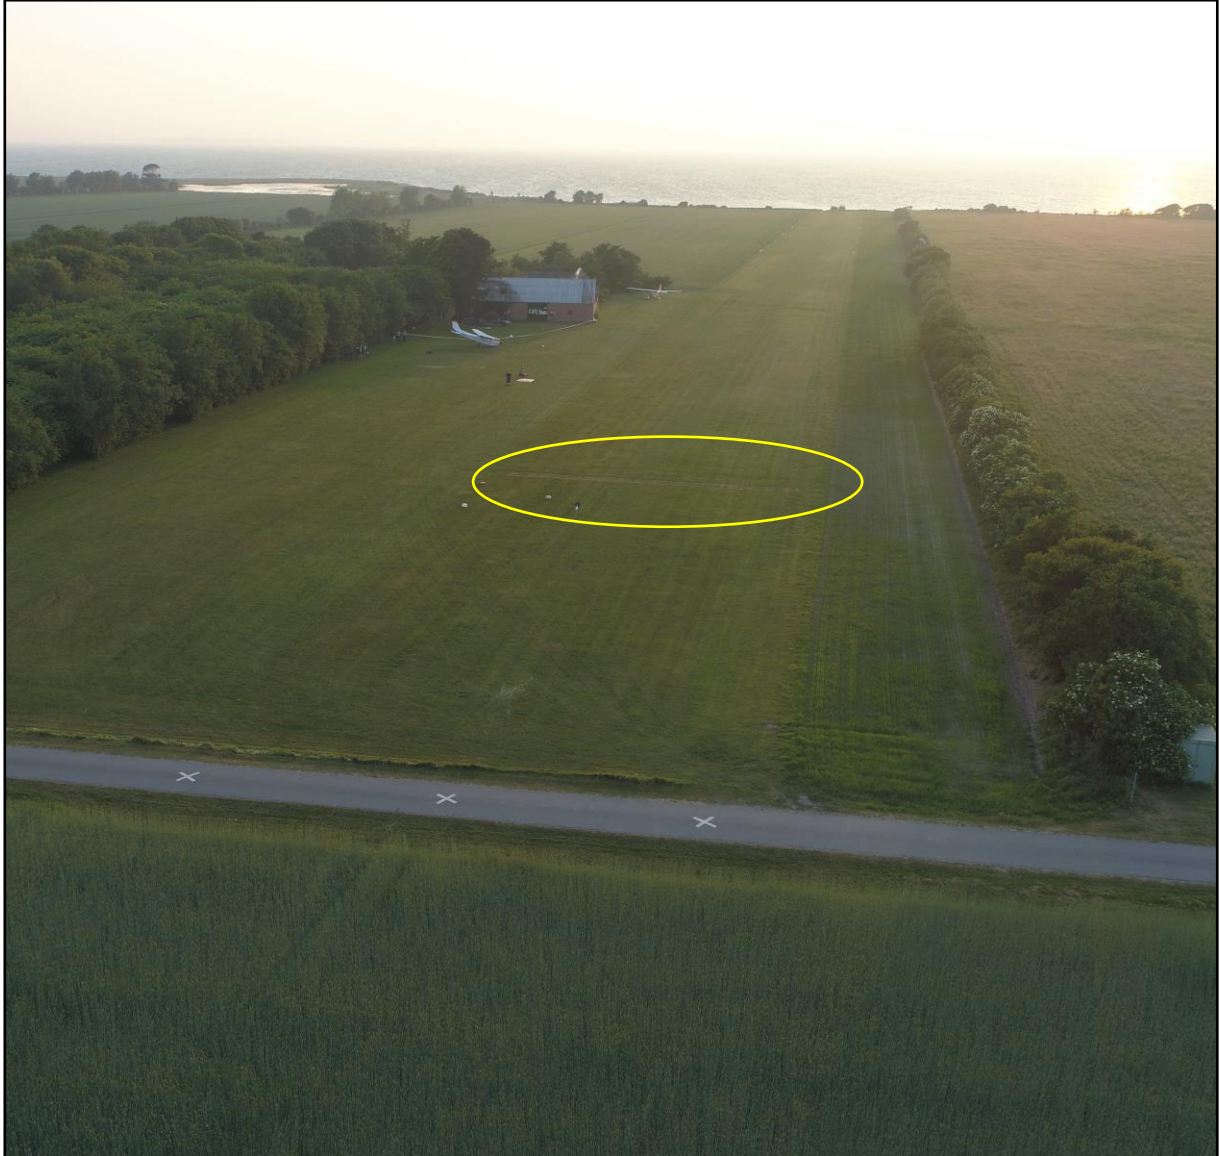
APPENDIX 3

Furthermore, by mowing the grass in a specific way across the airstrip approximately 50 meters west of the beginning of runway 29 the airstrip owner encouraged pilots to make use of the mowed displaced threshold.

See marking in yellow at [appendix 3](#).

A red and a white plastic can located to the right of the specific mowed area marked the displaced threshold to runway 29. During the rescue mission, someone removed the plastic cans. For that reason, appendix 3 does not present their right position.

Three painted white crosses on the road perpendicularly to the beginning of runway 29 had the purpose of warning pilots of not to land short of runway 29 and preventing car parking in the marked area.

The three painted white crosses were visible from the air.

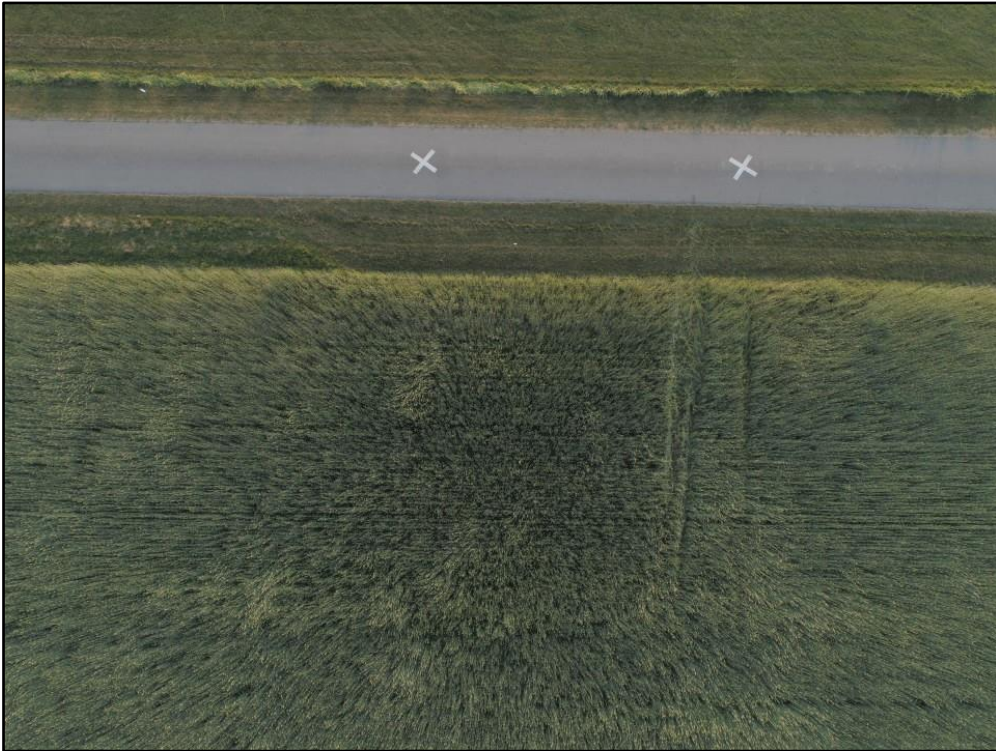
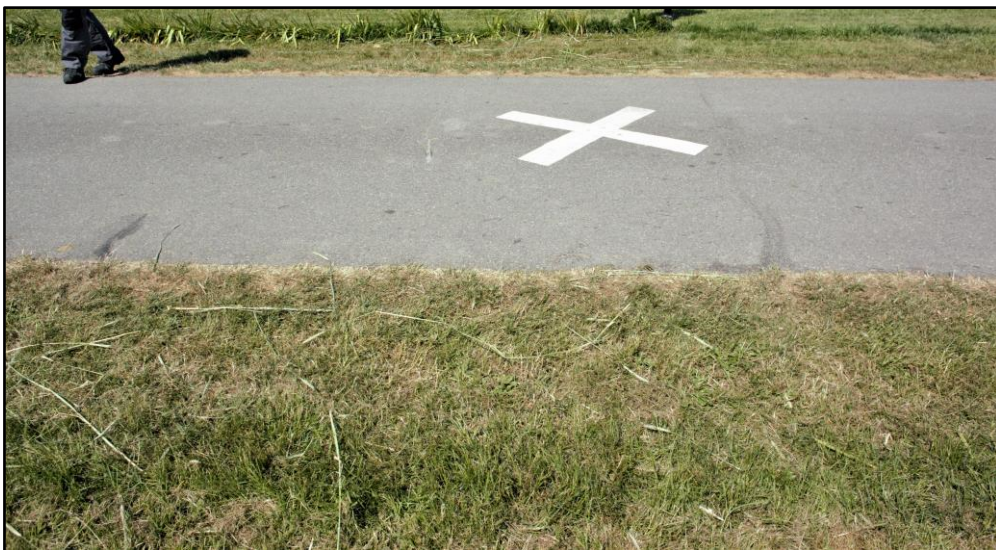
APPENDIX 4

- During the flare phase, the aircraft landed (right main wheel first) in a wheat field approximately 10 meters in front of the beginning of runway 29. See [appendix 4](#).
- The main landing gear touched down at and collided with an upslope roadside next to a road crossing perpendicularly to the beginning of runway 29.
- The left main landing gear collapsed. The aircraft crossed the road. See [appendix 4](#).
- The aircraft started an uncontrollable veering to the left.
- 142 meters from the beginning of runway 29, the left wing of the aircraft collided with the nose landing gear of a parked aircraft.

- The aircraft continued veering to the left, impacted with a tree and a farm building, and came to rest 160 meters from the beginning of runway 29.
