Havarikommisjonen
Accident Investigation Board Denmark

Report 2019-327

Report on accident to D-CAWM (Cessna 560 XLS+) at Aarhus (EKAH) on 5-8-2019.

ISSUED JUNE 2020

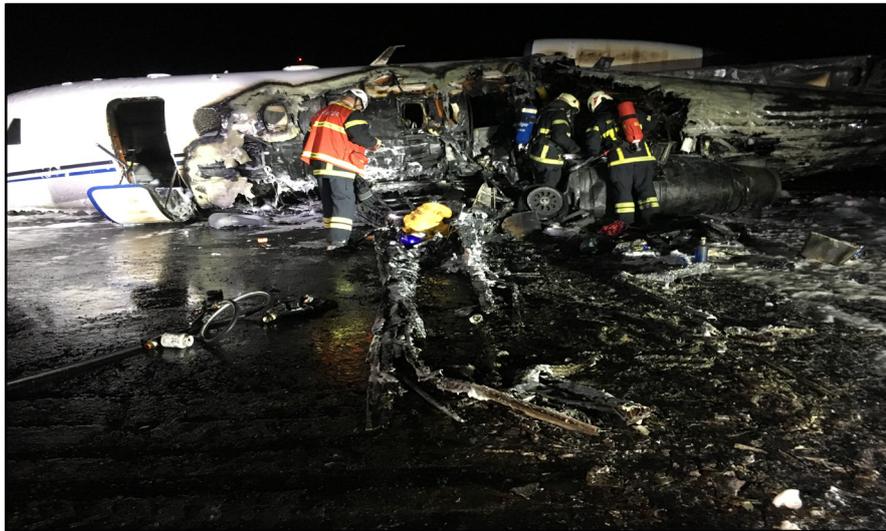
Photo no. 1. The wreckage at night.

The aircraft was destroyed.

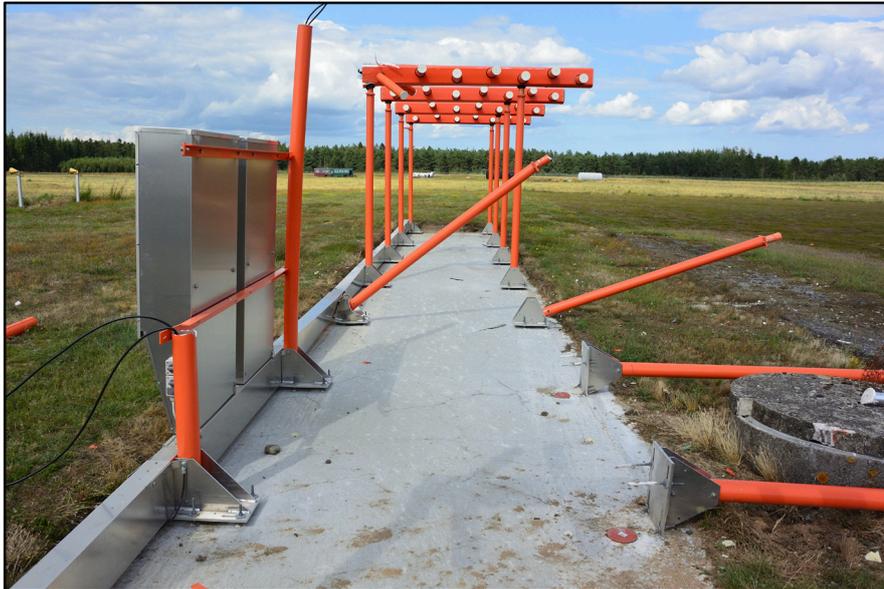
Photo no. 3. Damages to the antenna mast system of the LLZ for runway 28L.

- the antenna mast system of the LLZ for runway 28L located in front of runway 10R
- a near field antenna (LLZ for runway 28L) located on the extended centreline between the localizer antenna mast system and runway 10R
- the runway surface on runway 10R.

At collision with the antenna mast system located 450 meters before the beginning of runway 10R (measured from the green threshold identification lights), the left wing fuel tank ruptured resulting in a fuel leakage.

Collision with the antenna mast system resulted in damage to the left wing fuel tank causing leakage of fuel and fire.

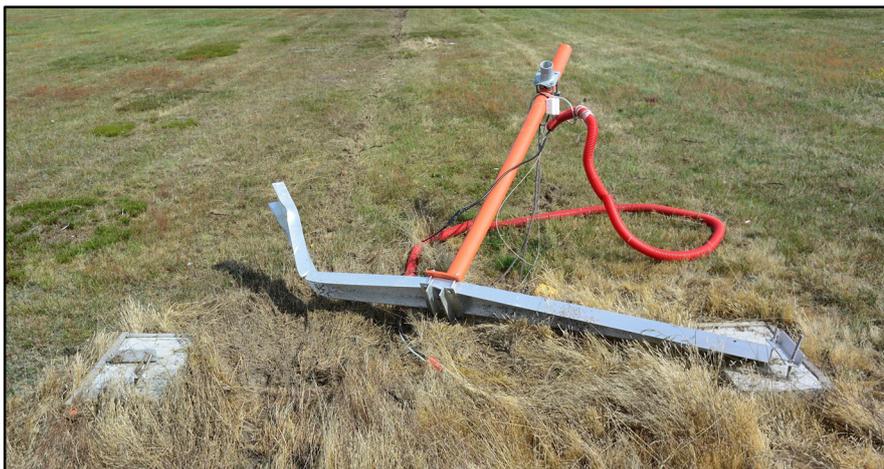
Photo no. 4. Damages to the nearfield antenna.

35. The left wing fuel tank ruptured resulting in a fuel leakage.
36. The aircraft touched down in the RESA for runway 28L.
37. After a landing roll of approximately 60 meters, the nose landing gear collided with the near field antenna of the LLZ for runway 28L and collapsed.

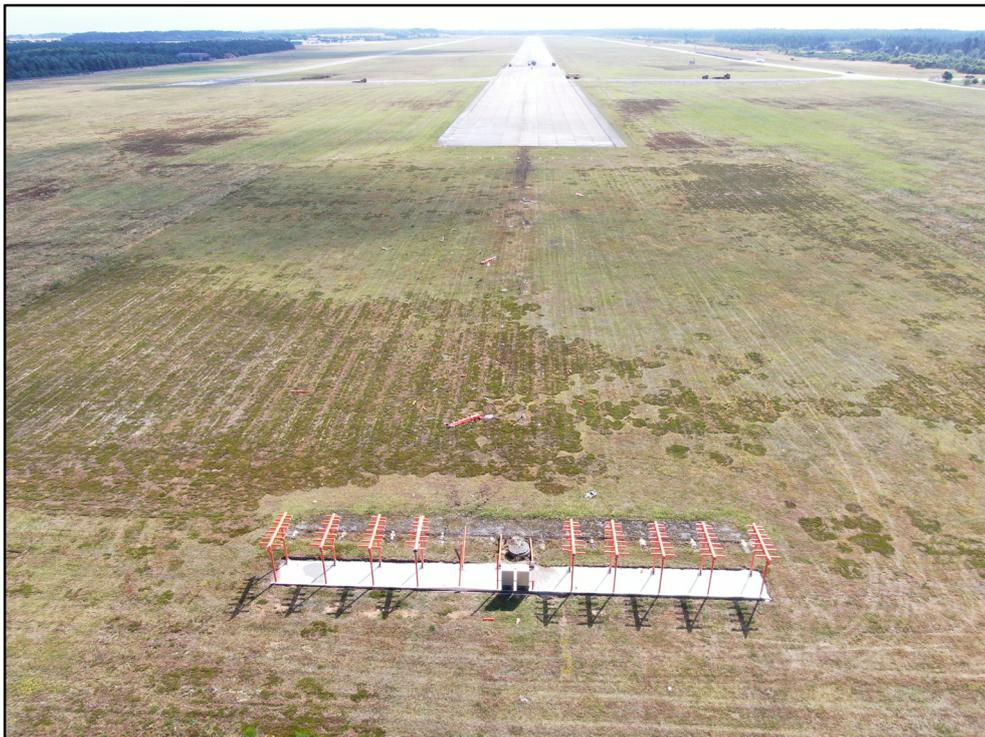
Photo no. 8. Impact area in front of runway 10R.

Approximately 230 m after the beginning of runway 10R (measured from the green threshold identification lights), the aircraft came to a full stop on runway 10R.

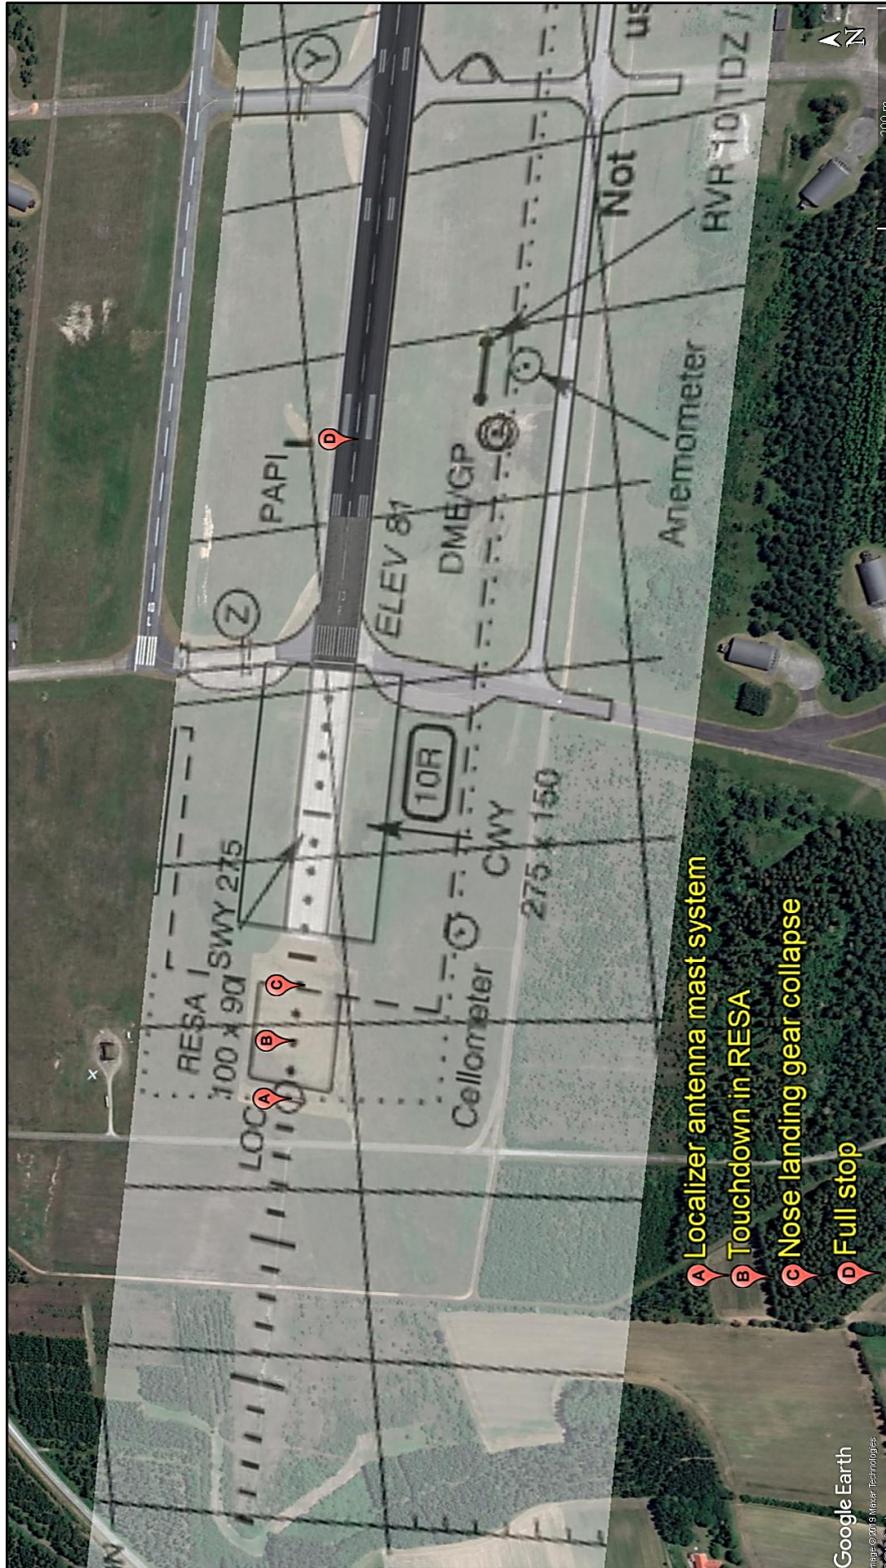
5.16 Wreckage trail

While rolling on the main wheels and skidding on the nose section, the aircraft entered the stopway for runway 28L.

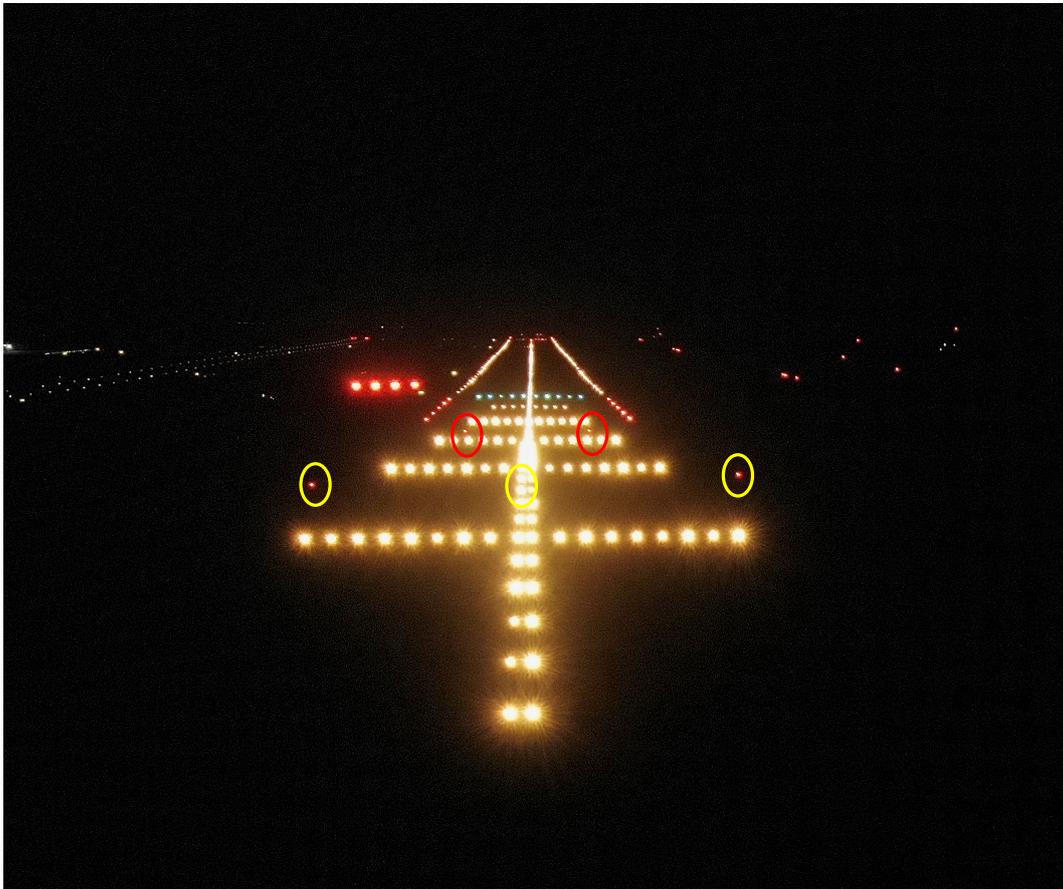
5.20 AIB drone photo no. 3

One of the red illuminated omnidirectional aerodrome fence obstacle lights (in the middle of the visible two, in yellow circles, red illuminated omnidirectional aerodrome fence obstacle lights) was located in the row of the approach centerline lights and for that reason not visible in this AIB drone photo.
