BULLETIN

Accident

8-2-2019

Airbus 321-251N

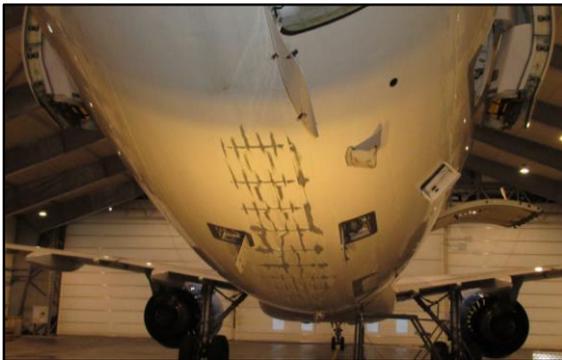
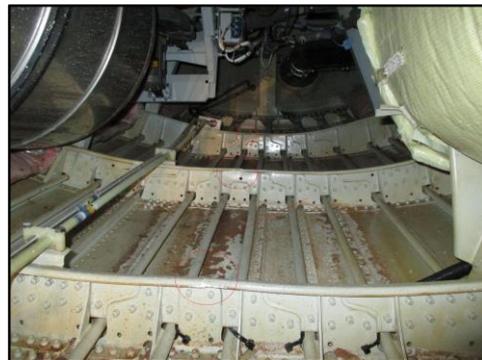
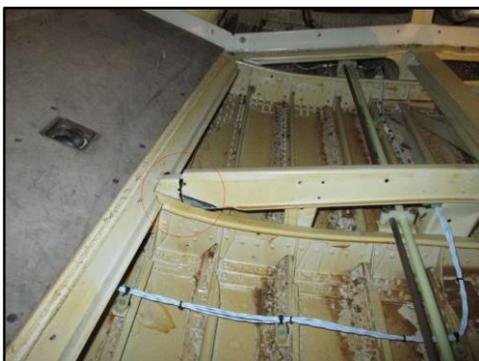
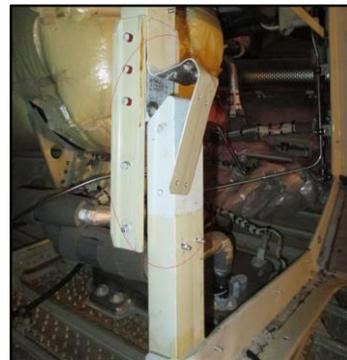
The aircraft tail section was substantially damaged.

The aircraft struck the runway at a recorded pitch angle of 9.49° and at a recorded G-load of 2.56 resulting in the following damages:

- The lower part of the aft fuselage skin was damaged between frame (FR) 60 and FR 69.
- The impact deformed several of the above-mentioned frames.
- Several floor beams cracked at their attachments to the frames.
- A vertical support strut attached to FR 65 sheared and indicated a significant vertical displacement.

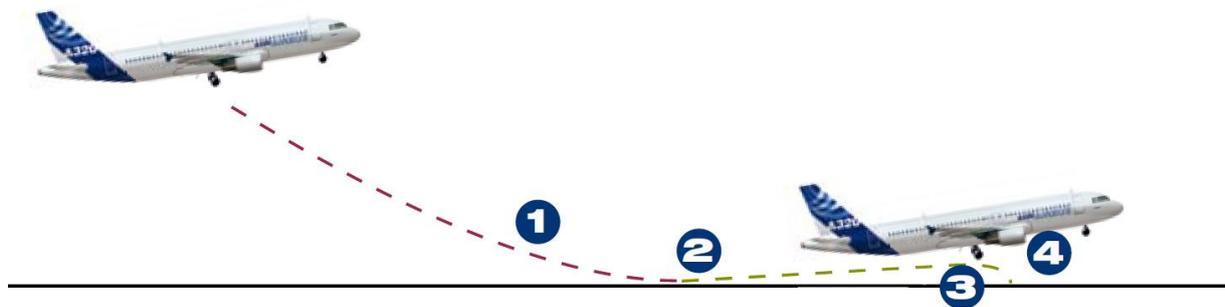
Landing scenario with SEC 120

1. *No engine throttle reduction (retard) during the flare - No ground spoiler extension.*
2. *With the SEC 120 modification, the ground spoilers will extend partially at touchdown, as long as both engines levers are at or below the Climb notch (ATHR). Lift is decreased and the bounce is reduced or cancelled.*
3. *As soon as the thrust lever conditions are fulfilled (for instance engine throttle reduction to Idle), the ground spoilers extend fully (if achieved within 3 seconds of the initial touchdown).*
4. *As the height of the bounce is significantly reduced, the vertical speed at the second touchdown is largely reduced as well.*

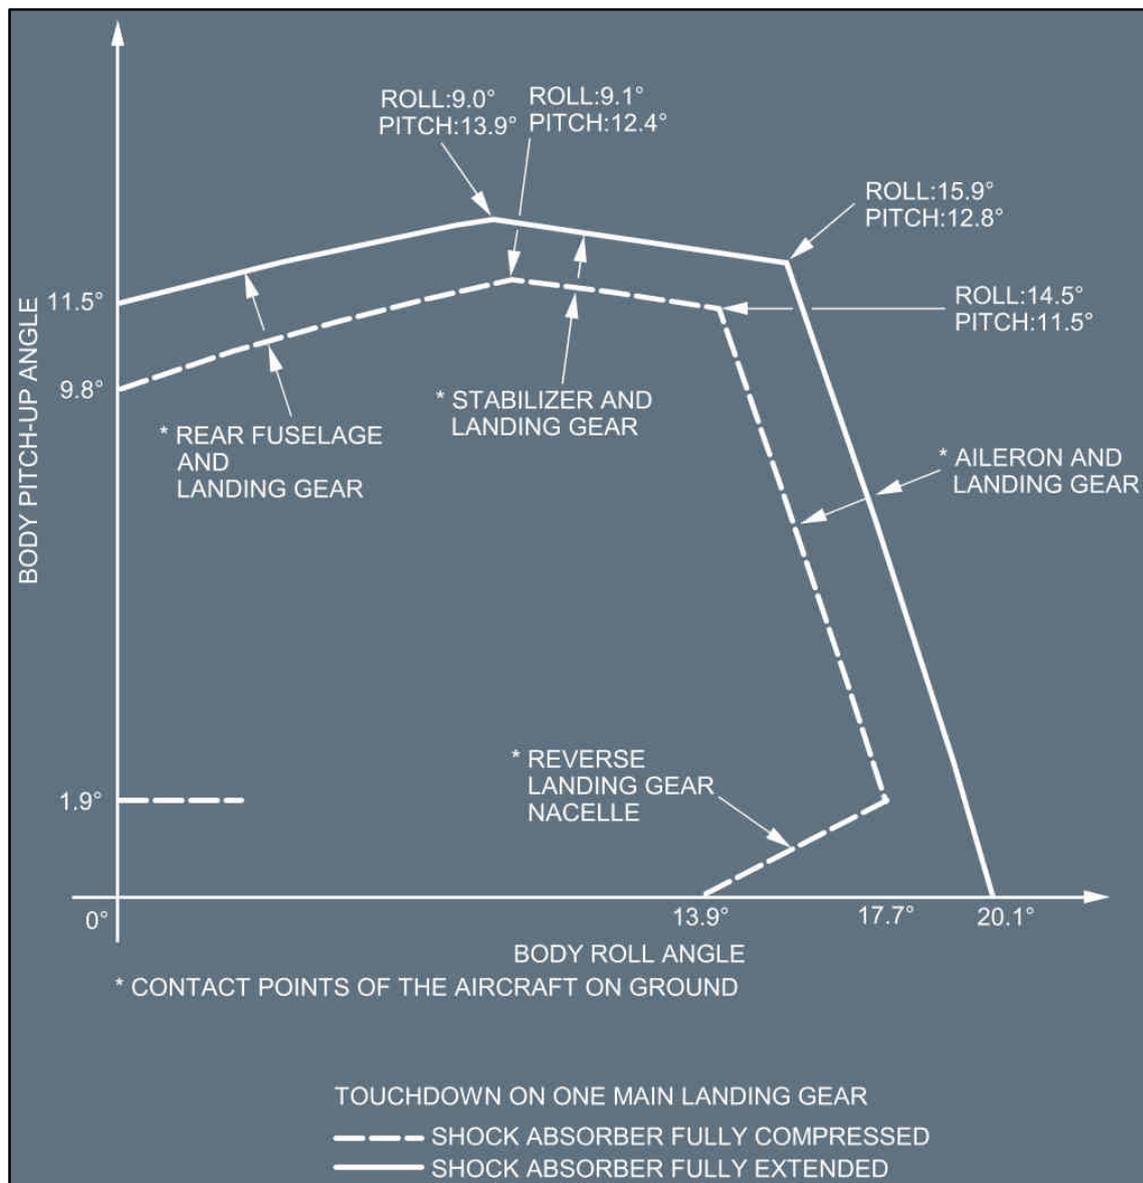
Ground clearance diagram

The FCOM ground clearance diagram is geometrically based. It indicates a pitch of +9.8° with a null roll and main landing gear compressed to have contact with rear fuselage.

This diagram does not take into account any combination of tolerances associated to the flexibility effect experienced by structure / landing gear / inertial reference system during the dynamic of hard landing motion and/or associated to the local slope or bump of the runway.

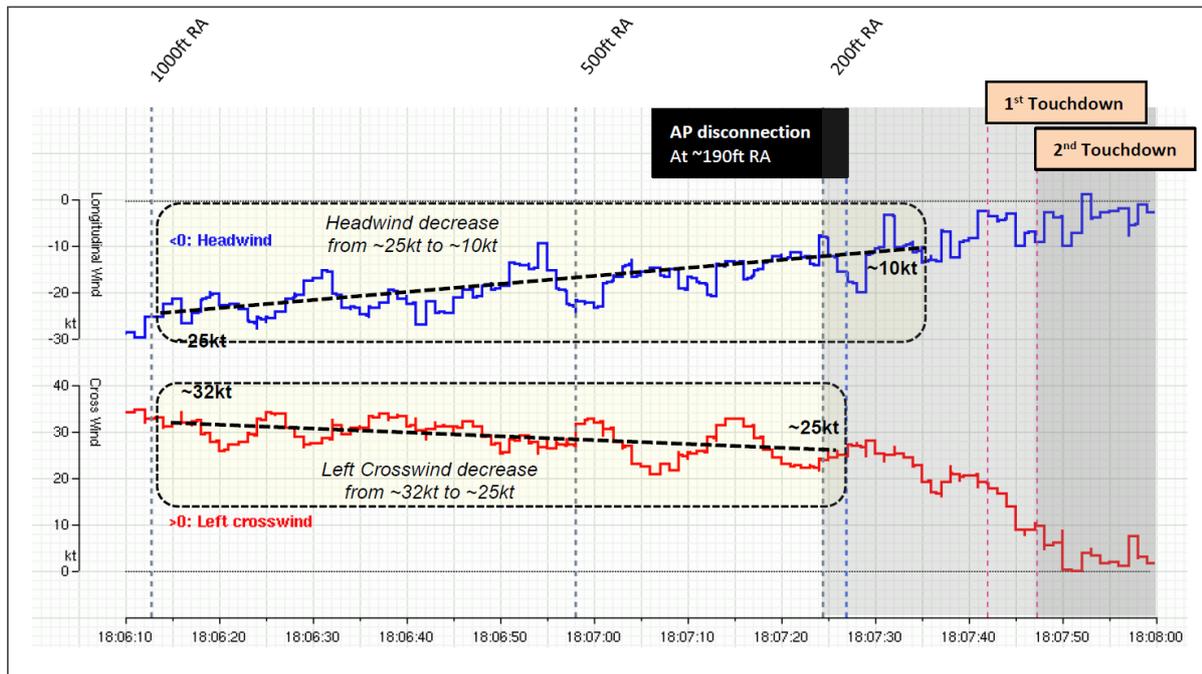
The aircraft manufacturer made a computation on wind evolution during the final approach.

The wind information computed by the Air Data Inertial Reference Unit (ADIRU), recorded by the FDR and projected on aircraft axes was as follows:

On ground - wind information not reliable.

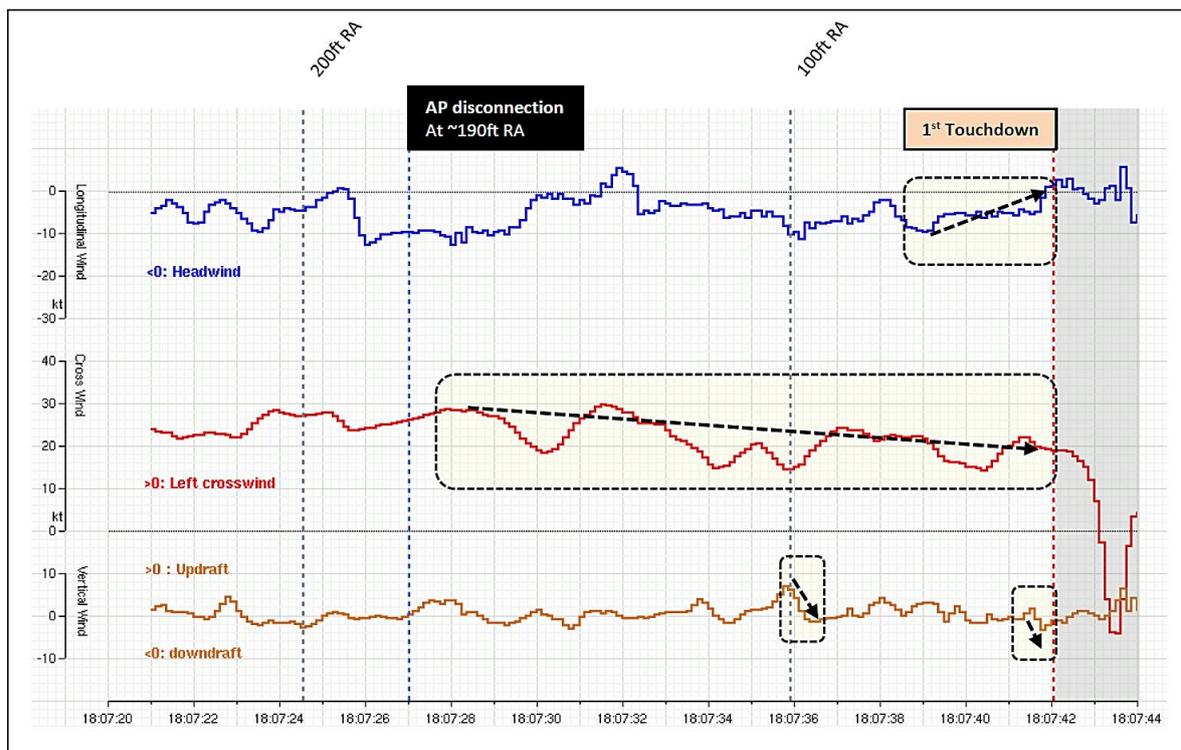
The wind reconstruction was computed in 3 axes, based on:

- Anemometric and Inertial data from FDR.
- Anemometric correction: estimation of sideslip and ground effects.
- Inertial bias reconstruction.

On ground - wind information not reliable.

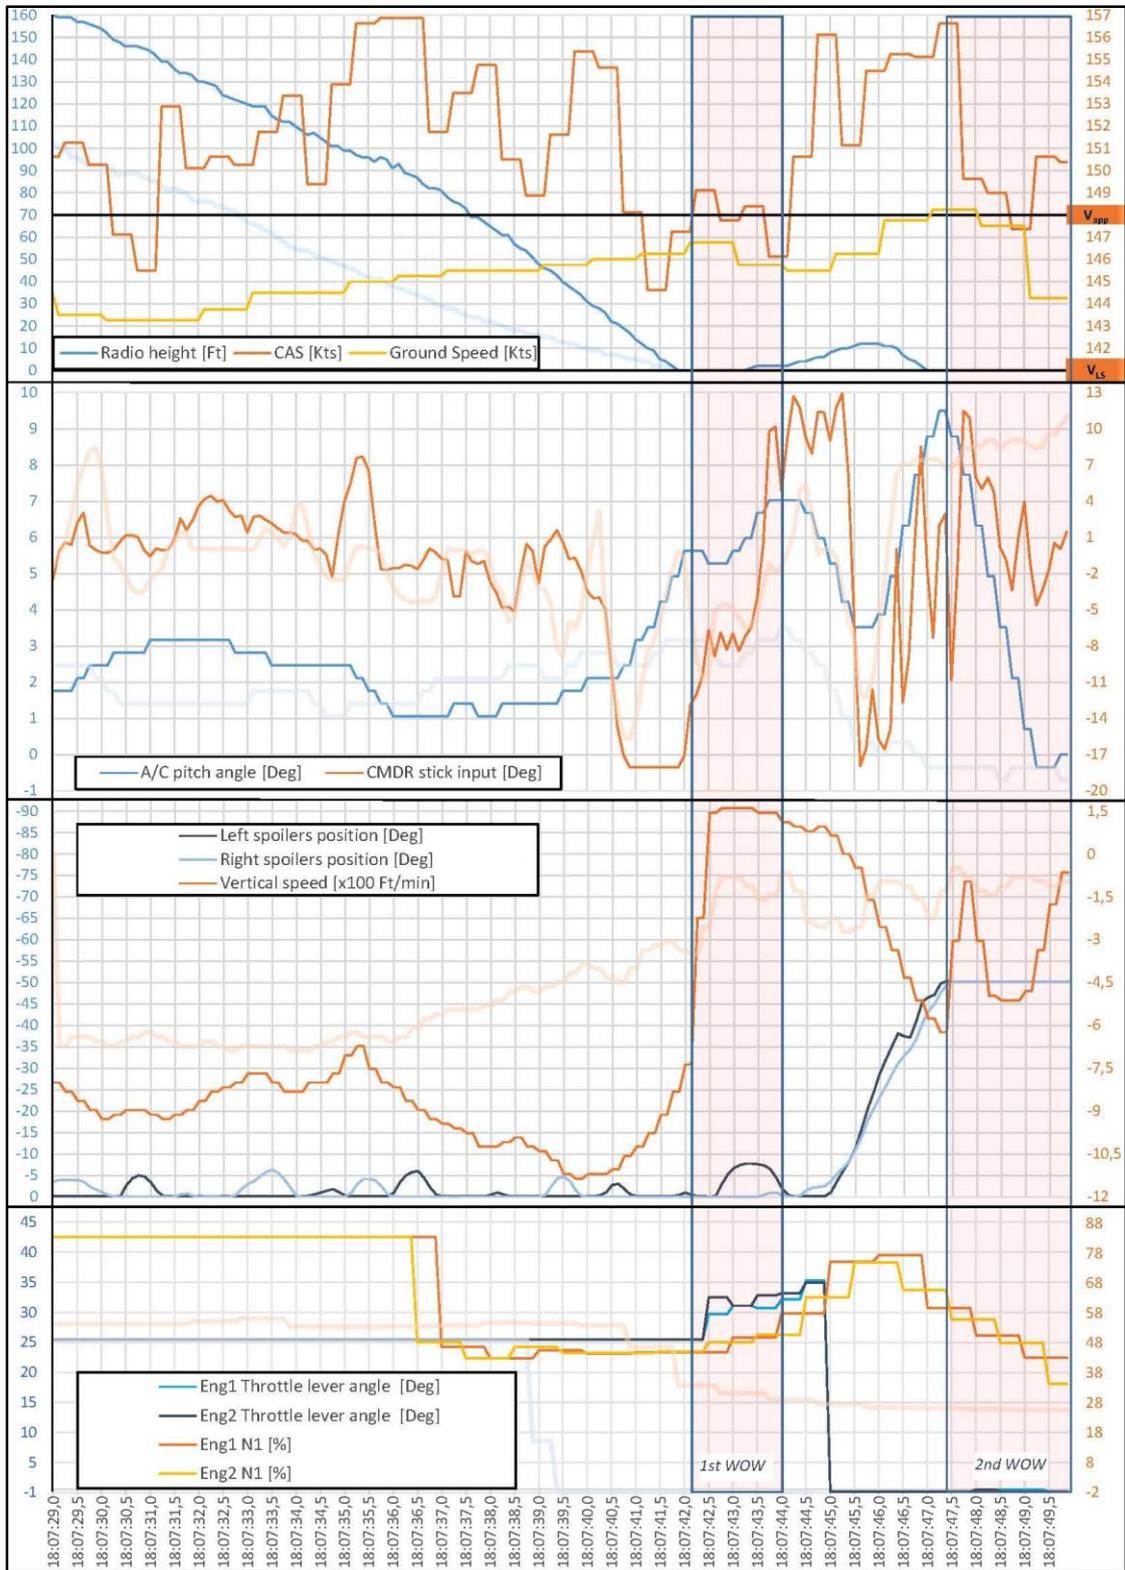
APPENDIX 3

[Appendix 3](#): From 160 ft RH, initial touchdown, bounce and final touchdown (plot).

Additional to extracted QAR data for the accident flight, the plot represents in shadowed lines recorded QAR data from another flight for comparison (Radio Height [Ft], A/C pitch angle [Deg], Vertical speed [x100 Ft/min], Eng1 Throttle lever angle [Deg], and Eng1 N1[%]).
