Havarikommisjonen
Accident Investigation Board Denmark

BULLETIN

Serious incident

BEECH 33 E33A

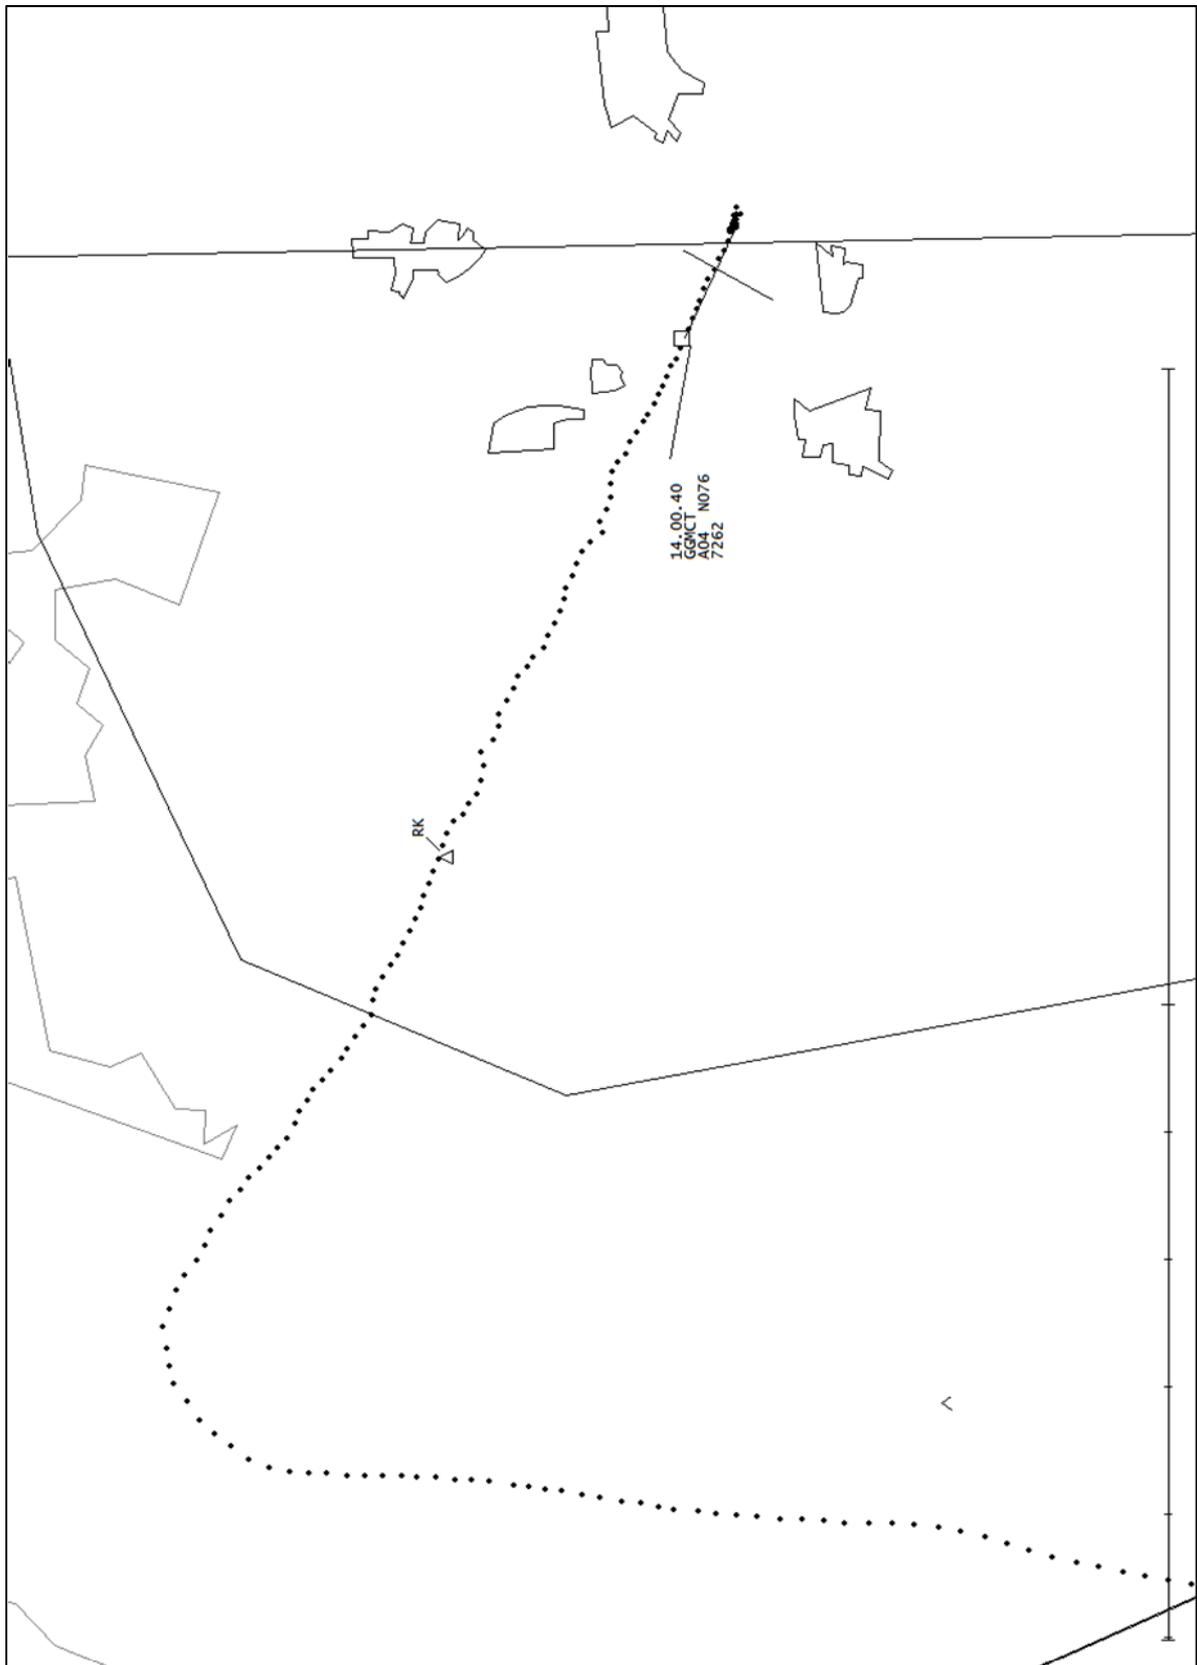
Appendix 1 - Radar plot

When the aircraft crossed the threshold to runway 11, the air traffic controller observed a radar presentation of the aircraft of 400 feet and a ground speed (GS) of 76 knots. [See appendix 1 - Radar plot.](#)

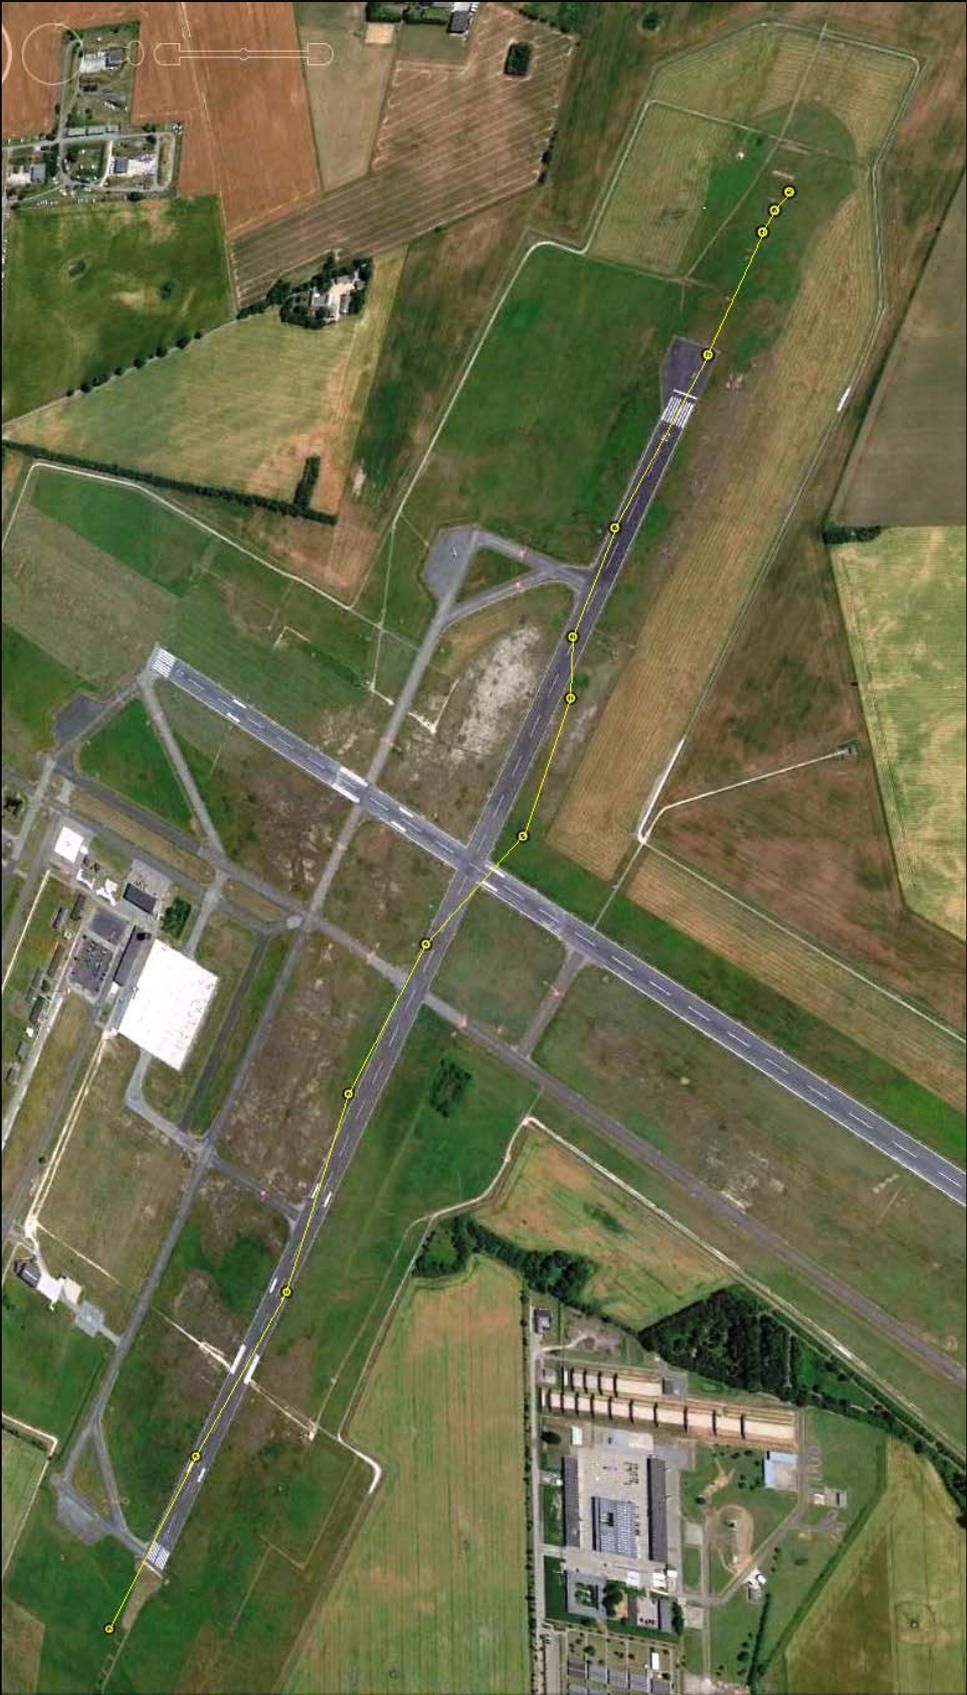
Appendix 5 - The landing phase

Due to the low visibility, two witnesses standing on the apron in front of the terminal building had no visual contact with the aircraft. However, they both heard the aircraft flying by with the engine power above idle. It was the perception of the witnesses that the aircraft did not touch down until it had passed the crossing of the runways 11/29 and 03/21.

The pilot was not able to stop the aircraft within the remaining available runway length, and the aircraft departed the runway end. The aircraft came to a stop in the grass area 200 meters beyond the runway end.

- The weather conditions for performing an ILS approach to runway 11 were marginal
- The pilot did not make use of the autopilot, which increased pilot workload
- The aircraft was not fully configured for landing (the before landing checklist was not completed leading to flaps set to an intermediate 20 degrees position)
- The final approach speed was approximately 10 knots higher than the recommended final approach speed
- The aircraft crossed the threshold to runway 11 at a radar presented altitude of approximately 400 feet mean sea level (msl) instead of crossing at an optimum altitude of 197 feet msl
- When crossing the threshold to runway 11, the aircraft was not stabilized (altitude, airspeed, and aircraft configuration)
- The pilot did not abort the approach and landing
- The aircraft touched down in the last third of runway 11
