FINAL REPORT

HCL 06-510/255 Accident			
Aircraft	Beech Baron BE58	Aircraft Registration	G-BXNG
Engines:	2 – Continental IO-520	Type of Flight:	Private, IFR
Crew:	1 – no injuries	Passengers:	1 – no injuries
Place:	65 14 061N 043 14 397W	Date and Time:	10.7.2006 1438 UTC

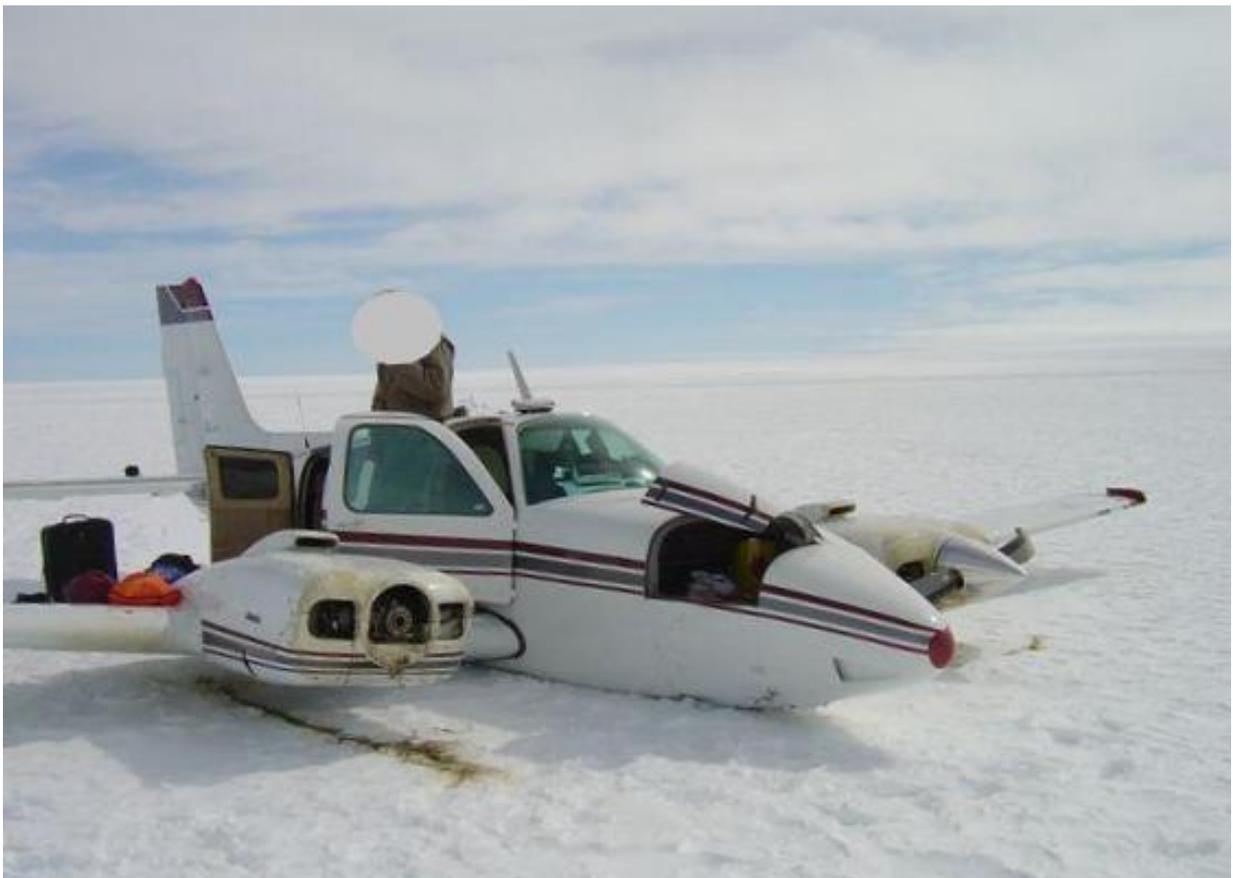
On a westerly course in a wings level attitude, the aircraft impacted the ice cap at 65 14 061N 043 14 397W (15 nm east of the waypoint SOBVI) and at an elevation of about 8100 feet msl. The impact pattern was consistent with a controlled shallow decent. The aircraft impacted with the landing gear and the flaps in the up position. The left propeller tips were bended backwards (low power/wind milling). The right propeller separated from the engine at impact (high power).

Towards the west, the ice cap was rising. Towards the east, the ice cap was falling.
