Havarikommisjonen
Accident Investigation Board Denmark

BULLETIN

Serious incident

ATR72-201

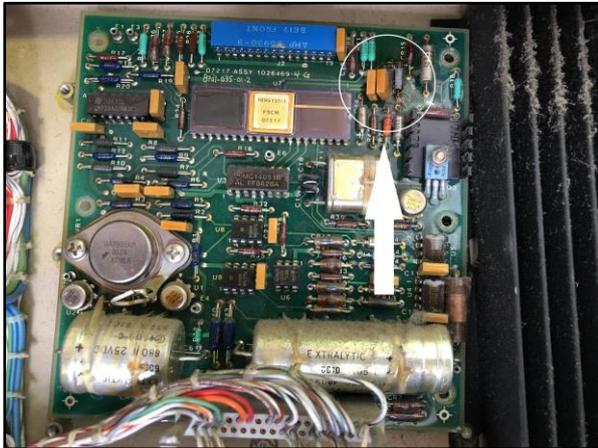
Front side

Inspections in the area forward of the rudder pedals, identified a small trace of electrical burnt smell from the R/H windshield heat controller. Initial visual inspection indicated, that a possible overheating of electrical components within the R/H windshield heating control box could be the source of the smell/smoke.

The control box was sent to an approved repair shop for inspection. The inspection stated the condition of the control box as “Dirty”. A subsequent bench test of the control box revealed *No fault found*.

Dirt in electrical components has previously produced smell and/or smoke when subjected to electrical power. The shop inspection of the R/H windshield heat controller stated presence of *dirt*, but the subsequent test did not produce any smoke or smell.

Following the replacement of the above-mentioned component and a test flight, the operator returned the aircraft to service on 23-2-2019.

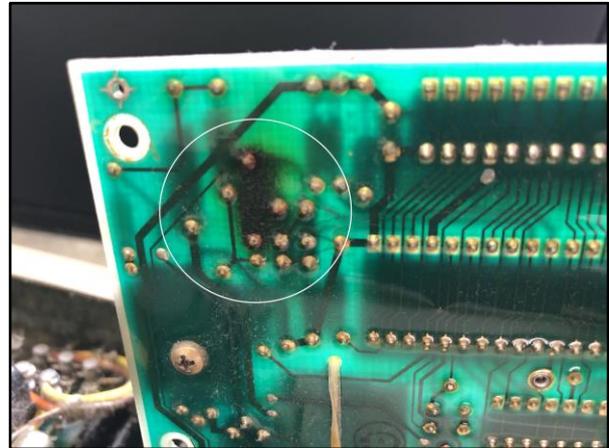
Back side indication of possible overheating damage to component/welding
