Havarikommisjonen
Accident Investigation Board Denmark

BULLETIN

SIKORSKY S61N

OY-HAG

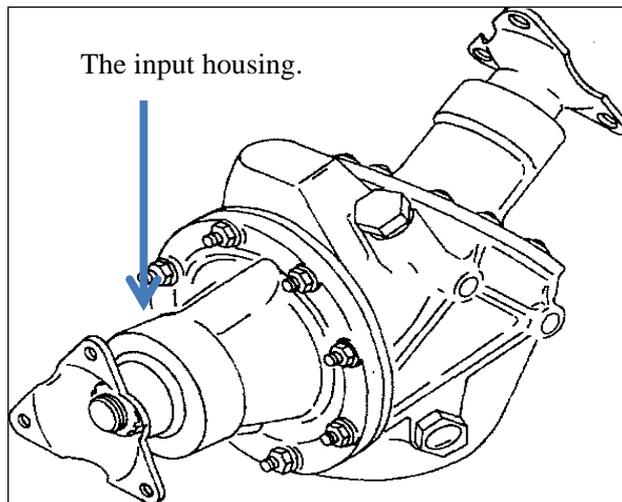
The intermediate gear box assembly

During the inspection, failure to the input gear bearing was found, and the input gear cone was overheated. Furthermore, the oil dam was found dented.

- The oil dam, all bearings, cups, cones, and packing's for the input and output seals were replaced.
- Oil lines were thoroughly checked to be clear of any contamination.

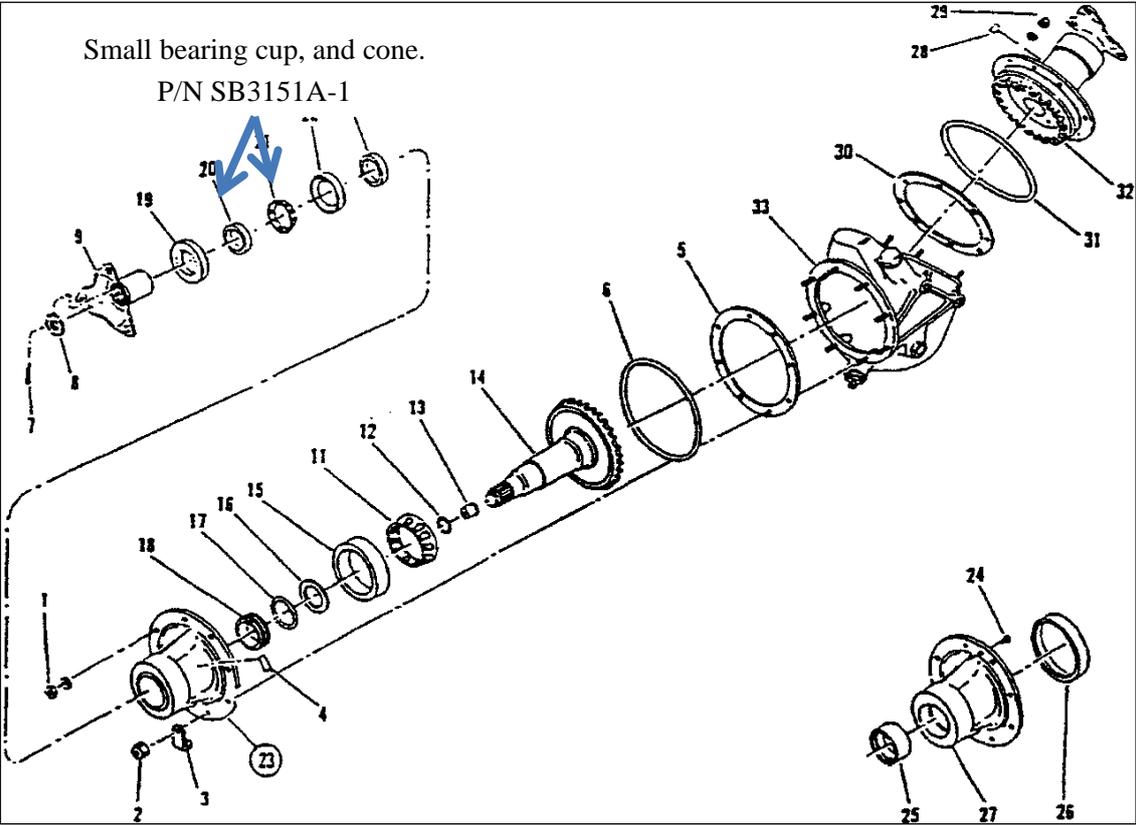
On the ramp, it was observed that the intermediate gear box was discolored from excessive heat around the area of the input bearing. A piece of approximately 10 by 4 centimeters of the intermediate gear box input housing had broken off.

The intermediate gear box input housing damage, and discoloring.

“Field occurrence-Input housing overheat fracture. Due to the severely damaged condition of the components, the initial cause of the failure of the input tapered roller bearing was not evident.

However, another input tapered roller bearing that had reportedly been replaced during an overhaul ~50 hours prior to an IGB overheat incident evidenced overheating indications to the inner ring and rollers, and roller scoring damage at the large end cage pockets.

Tapered roller bearing damage might be due to inadequate lubrication.
