Avoidable Accidents No. 6

Experience won't always save you

Pilot experience is not always a protection against an accident

Research AR-2012-035

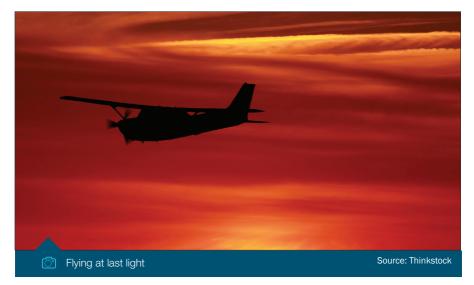
Due to loading delays, the departure from Margaret Bay was later than the planned time that permitted a return to Cairns in daylight. However, the pilot departed with the stated hope that he could probably make better time in more favourable winds at lower altitude. The pilot continued flying toward Cairns, passing the aerodrome at Cooktown where conditions would have permitted a landing in daylight to be made. South of Mossman the aircraft was observed flying above the shore at very low-level, in approaching darkness and in conditions of poor visibility in light rain.

Although the pilot was provided with radar guidance to the runway he was unable to see the approach or runway lighting and land. During positioning for a third attempt to land the aircraft disappeared from radar over the water. People on the shore heard the aircraft and an impact with the water. A search found the body of the passenger later that night, but failed to locate either the pilot or the aircraft.

About 3 months later, the wreckage of the aircraft was found in shallow water and some of the components recovered. Damage to the recovered aircraft parts suggested that the aircraft had impacted the water heavily and that the accident was not survivable. The circumstances of the accident were consistent with the pilot experiencing spatial disorientation and subsequent loss of control while manoeuvring the aircraft in darkness and poor weather without adequate visual cues.

Once the flight departed Margaret Bay, the pilot was committed to delivering a valuable and perishable cargo. The acceptance of an injured passenger may also have added to the pilot's sense of urgency to complete the flight. The investigation found that the pilot had no contingency plan should darkness and poor weather conditions force him to land at other than his planned destination.

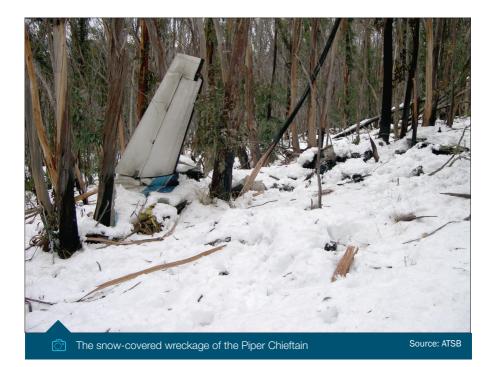
On 8 July 2005, a Piper PA-31 Chieftain disappeared while attempting to land in the Victorian Alps at Mt Hotham in poor weather conditions and failing daylight.

The destination forecast predicted icing conditions in the Mount Hotham area and indicated that conditions could be expected to be below the landing minima. In the two telephone discussions with the Mount Hotham airport manager, prior to departing Essendon, the pilot was advised of low cloud, poor visibility and snow showers in the vicinity of the Mount Hotham aerodrome. During a conversation between the pilot and his chief pilot prior to departing Essendon, consideration had been given to deferring the flight until the weather at Mount Hotham improved, but the pilot reportedly advised that his passengers were adamant that if possible, they would like to fly to Mount Hotham that afternoon.
