Havarikommisjonen
Accident Investigation Board Denmark

Bulletin 2022-117

Accident to N745AJ (Cirrus SR22) 3.8 nm south of Ringsted (EKRS) on 20-3-2022.

ISSUED JULY 2023

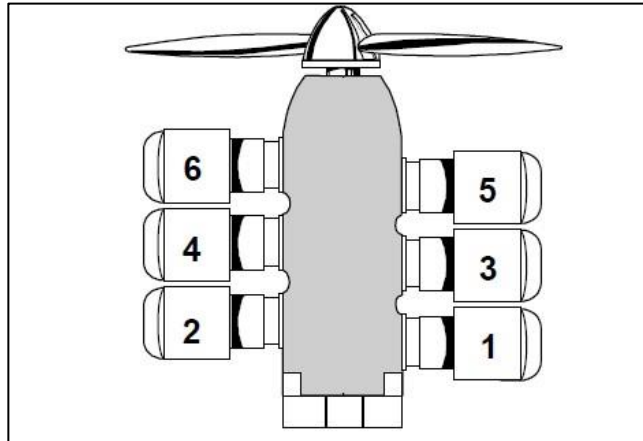
Photo 23. IO-550-N cylinder designation – top view.

The disassembly of the engine revealed the following defects and damages:

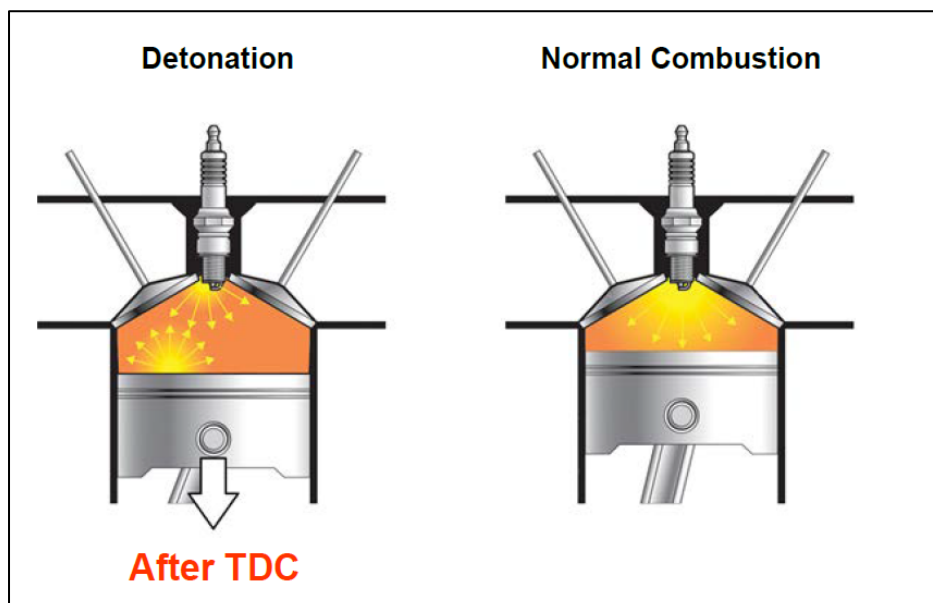
Photo 26. An illustration on engine detonation.

Other causes of detonation are improper ignition timing, high inlet air temperature, engine overheating, oil in the combustion chamber, or a carbon build up in the combustion chamber.

High heat is detrimental to piston engine operation. Its cumulative effects can lead to piston, ring, and cylinder head failure and place thermal stress on other operating components. Excessive cylinder head temperature can lead to detonation, which in turn can cause catastrophic engine failure. Turbocharged engines are especially heat sensitive.”
