**Havarikommisjonen**  
Accident Investigation Board Denmark

**Bulletin 2023-339**

**Accident to N44WN (Daher TBM 900) in Narsarsuaq (BGBW) on 17-6-2023.**

**ISSUED OCTOBER 2023**

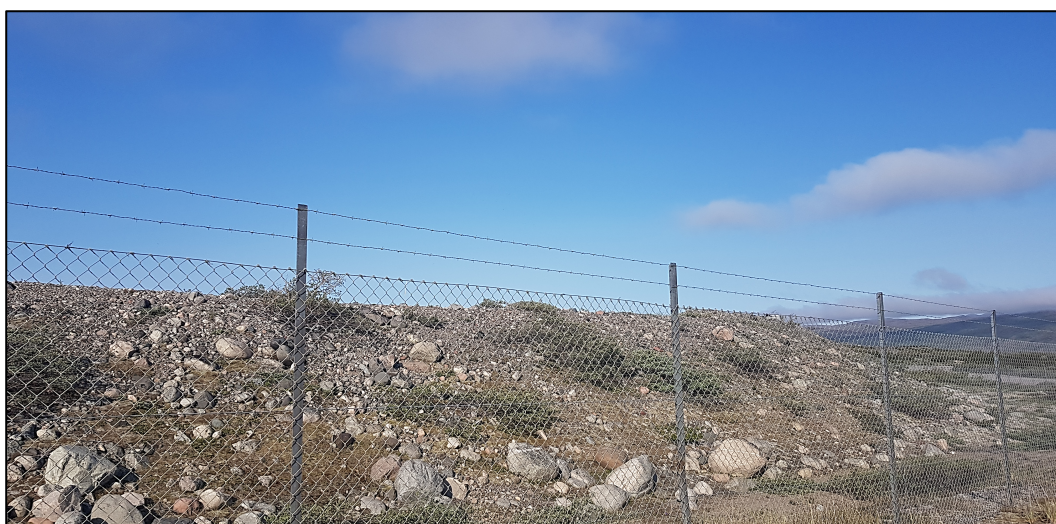
Figure 10. Aerodrome fence beyond the runway end to runway 06.

Beyond the runway end to runway 06 and below the elevation of the runway, a surrounding aerodrome fence crossed the area, perpendicularly to the runway direction,

Furthermore, the threshold lights to runway 24 and the aerodrome fence had no damages.
