Havarikommissionen

Report 2022-150

Serious incident to CS-TNV (Airbus A320-214) in Copenhagen/Kastrup (EKCH) on 8-4-2022

ISSUED FEBRUARY 2024

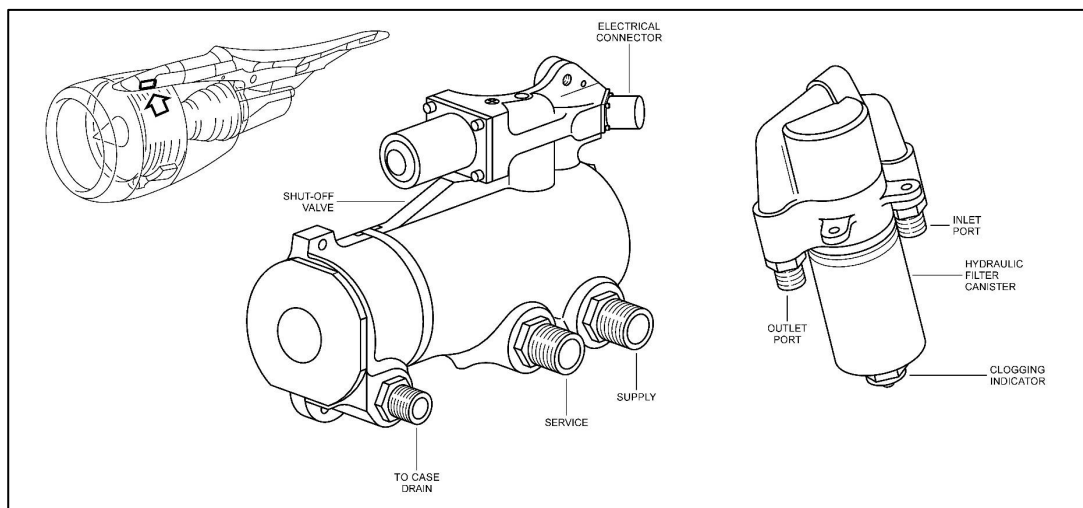
Figure 8. TRSOV and filter housing

The filter housing flow differential pressure test was slightly out of limit, and the shut off valve leak check failed. The operator informed that it had been a challenge in the past to test other filter housings within the CMM limit for the flow differential pressure test.

The leakage of the shut off valve also had no influence on engine #1 thrust reverser's inability to stow.

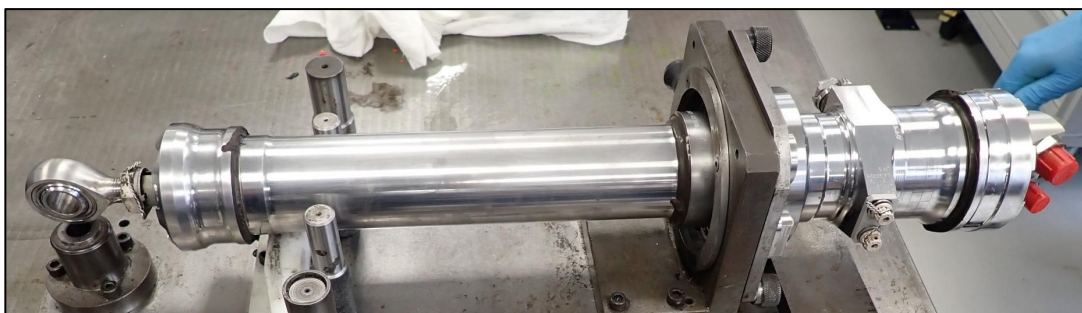
Figure 20. Actuator

To test the actual load capability, each actuator was tested to retract under different loads to find the maximum capability using the nominal recorded hydraulic pressure of the aircraft system (178 bar) at the time of the serious incident. Whether the actuator was able to retract and lock (internally/secondary) and the time taken to retract was recorded.

During the tests, all actuators behaved very similar and produced very similar results:
