# Havarikommissionen

## Report 2022-150

### **Serious incident to CS-TNV (Airbus A320-214) in Copenhagen/Kastrup (EKCH) on 8-4-2022**

ISSUED FEBRUARY 2024

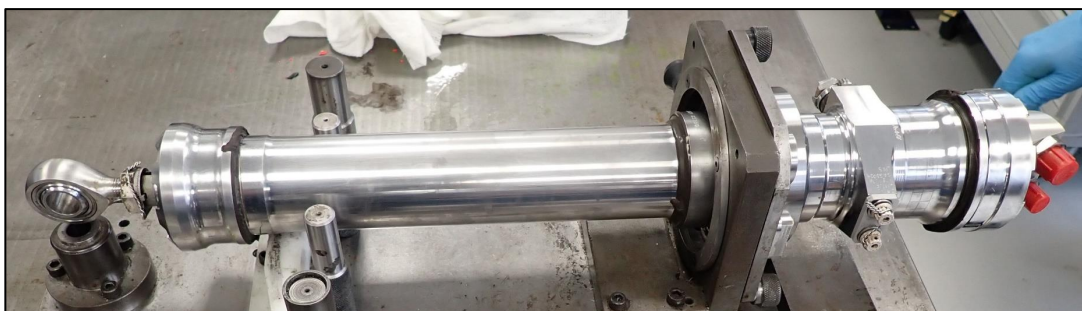
Figure 20. Actuator

To test the actual load capability, each actuator was tested to retract under different loads to find the maximum capability using the nominal recorded hydraulic pressure of the aircraft system (178 bar) at the time of the serious incident. Whether the actuator was able to retract and lock (internally/secondary) and the time taken to retract was recorded.

During the tests, all actuators behaved very similar and produced very similar results:
