Havarikommisjonen
Accident Investigation Board Denmark

Report 2019-327

Report on accident to D-CAWM (Cessna 560 XLS+) at Aarhus (EKAH) on 5-8-2019.

ISSUED JUNE 2020

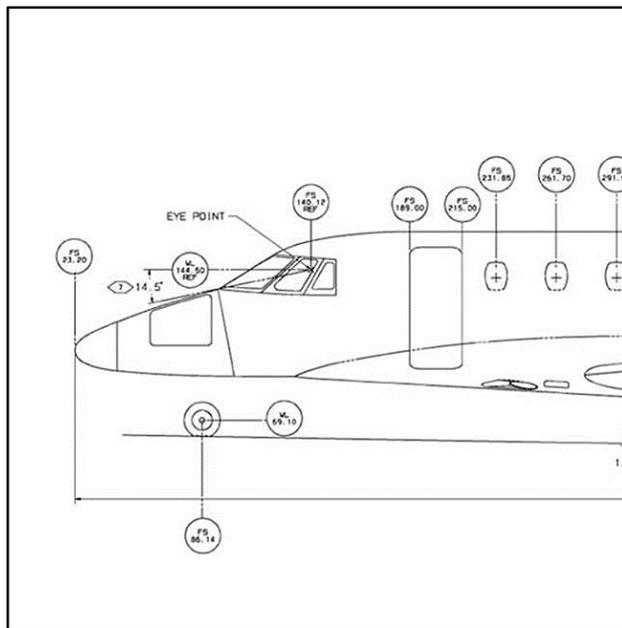
The drawing shows the designed eye reference point and the angle of visibility over the nose from that point, which is 14.5 degrees.

Photo no. 5. Angle of visibility over aircraft nose.

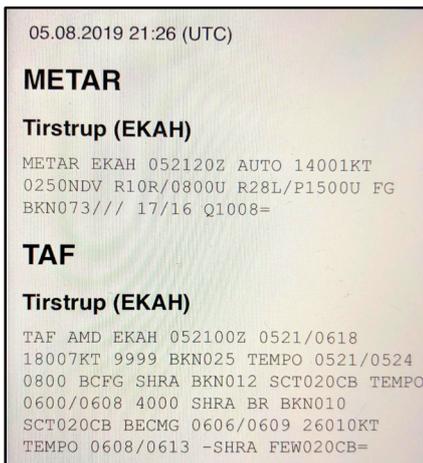
Photo no. 6. Latest TAF and METAR obtained by the commander before departure from ENGM.

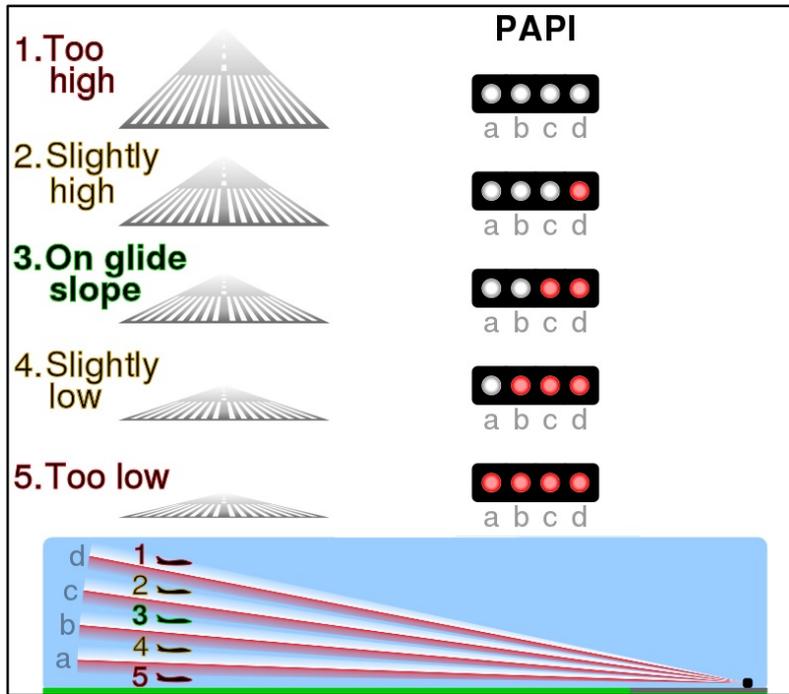
Photo no. 7. A generic illustration of PAPI indications. The source is Wikipedia.

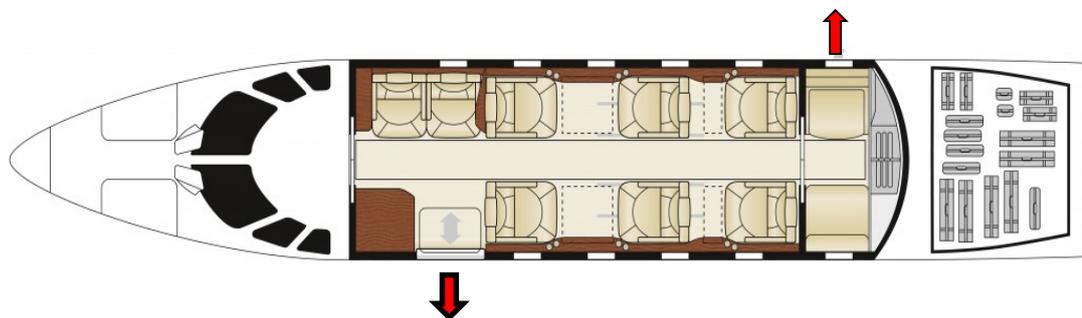
The aircraft had a seating capacity of nine passengers. Emergency exit door

Photo no. 9. Emergency exits. Cabin entry door

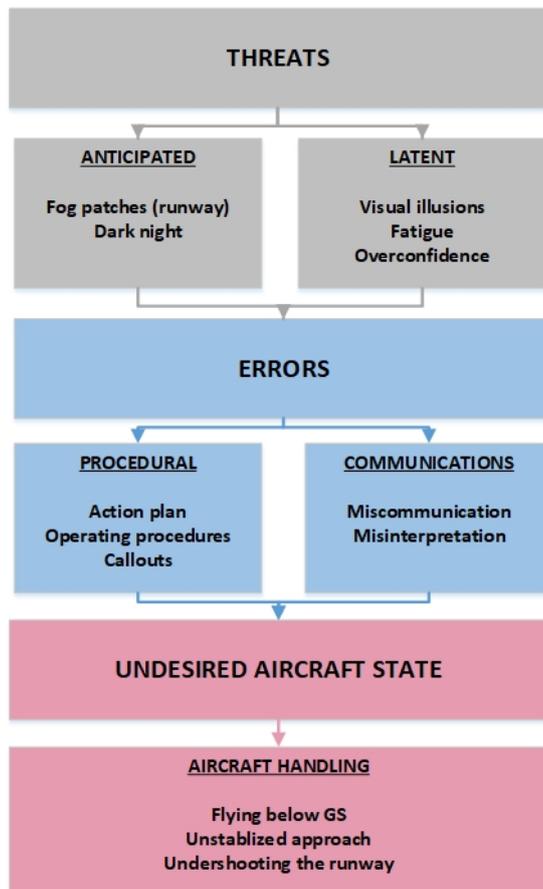
Photo no. 10. Threat and error management.

The commander mitigated a perceived threat (concern about entering fog patches during the landing roll) by an action plan on going one dot below the GS, performing a *towed approach*, and touching down on the threshold and thereby introducing and facing other operational threats. It seems unlikely that the flight crew was aware of the potential consequences of these introduced threats.
